**#Remand-25-1**

**Applicant  
Testimony and Rebuttal**

Re: Remand of Nedonna Development for Phase 2 PUD approval  
City file # Remand-25-1  
Our File No.: 5701.001

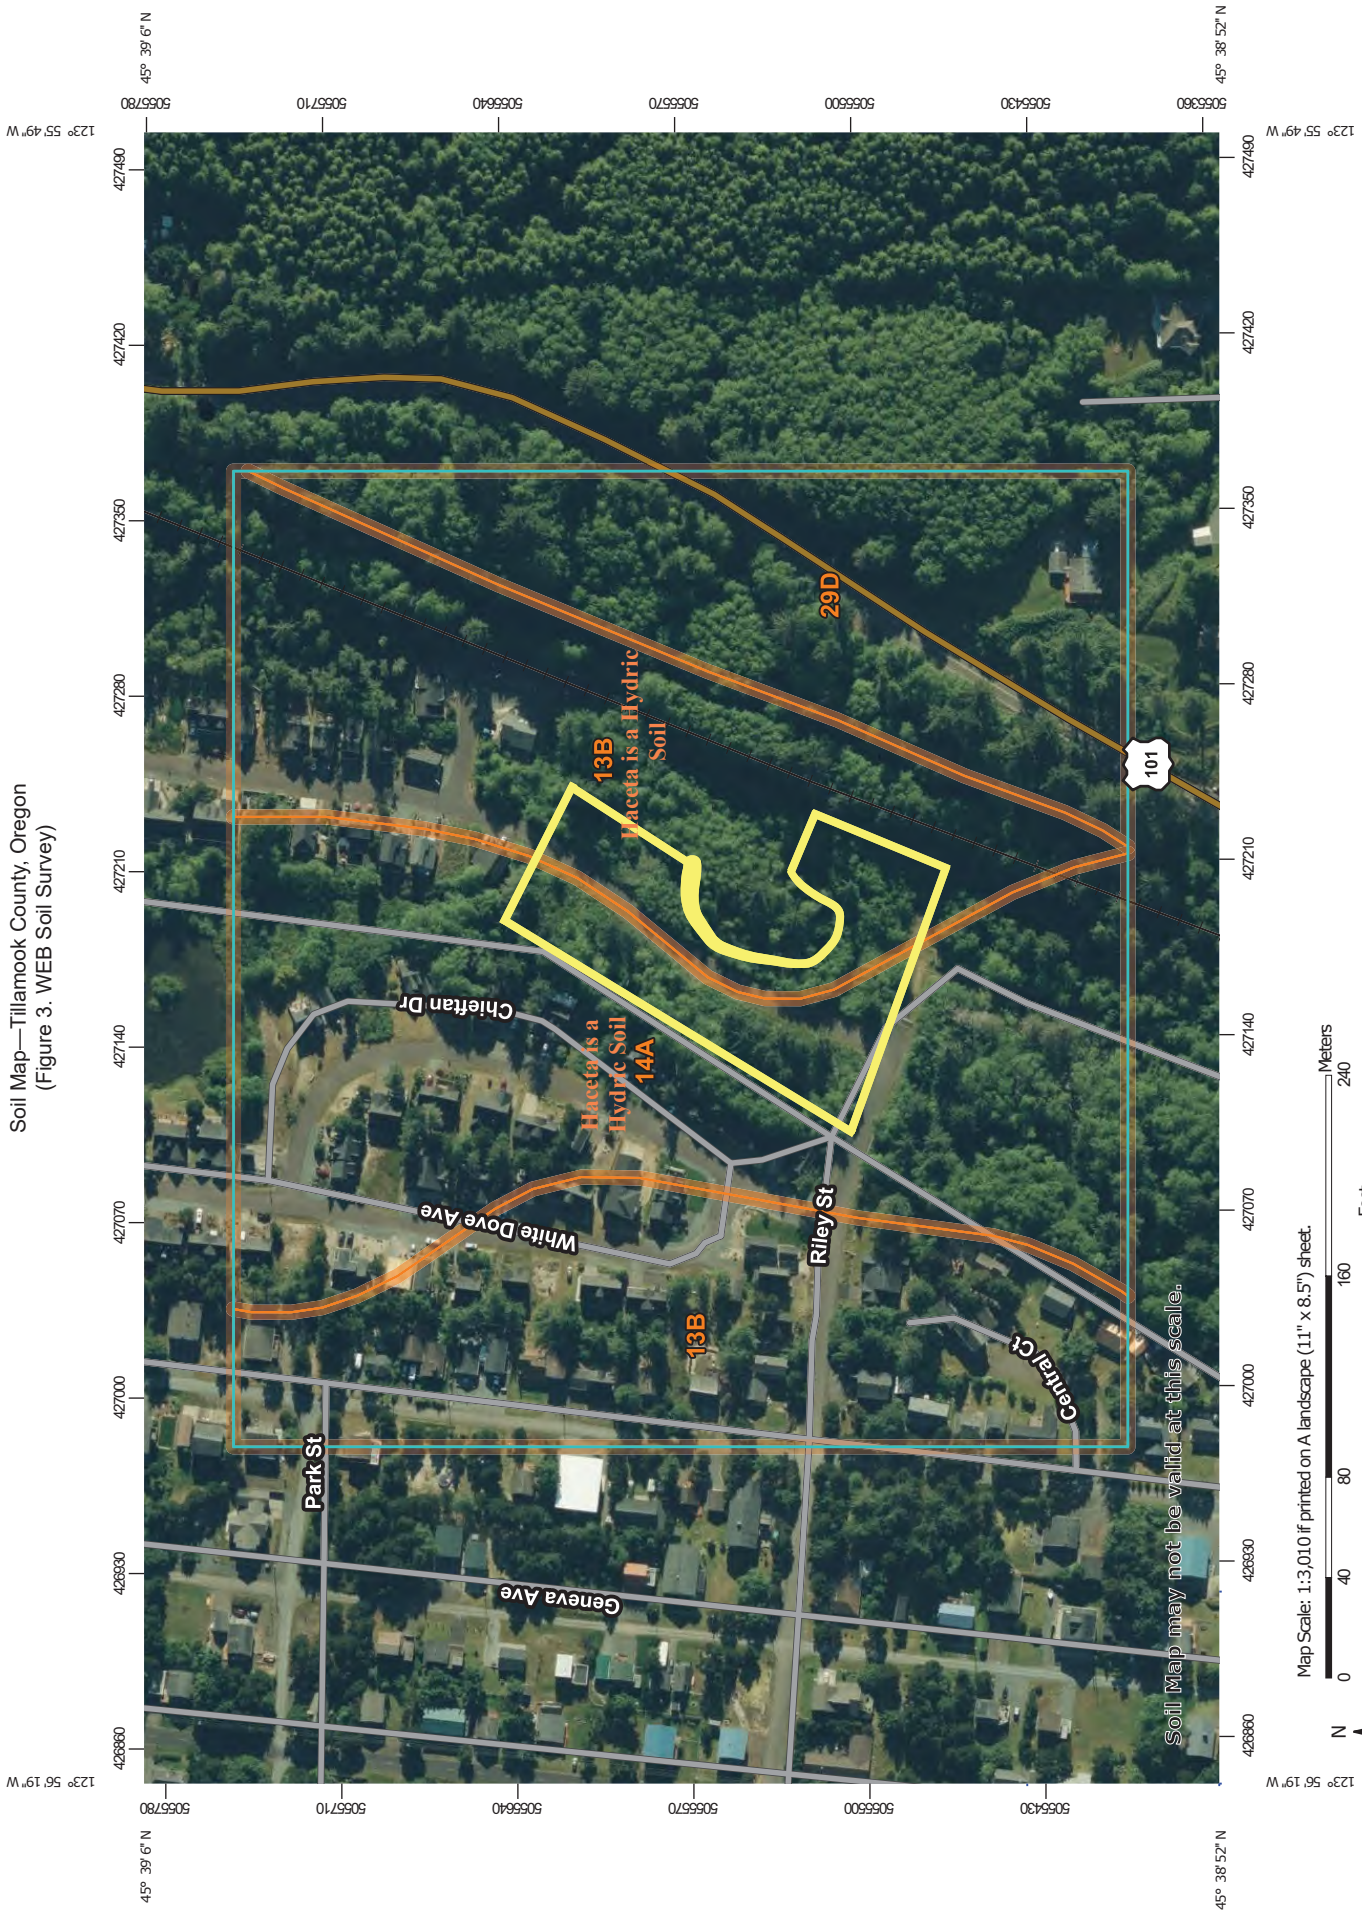
Soil Map—Tillamook County, Oregon  
(Figure 3. WEB Soil Survey)

The lot is located on stable duneland with subtle elevation difference between high and low points. Within the study area boundary, the Natural Resources Conservation Service (NRCS) has mapped the Haceta fine sand, 0-3 percent slopes (14A) and the Waldport thin surface-Haceta fine sands, 0-5% slopes (13B). The Haceta is a hydric soil (Figure 3).

Map Unit Symbol	Map Unit Name	Acres in AOI	Percent of AOI
13B	Waldport, thin surface-Heceta fine sands, 0 to 5 percent slopes	15.9	46.3%
14A	Heceta fine sand, 0 to 3 percent slopes	11.9	34.7%
29D	Templeton-Klootchie complex, 5 to 30 percent slopes	6.6	19.1%
<b>Totals for Area of Interest</b>		<b>34.4</b>	<b>100.0%</b>

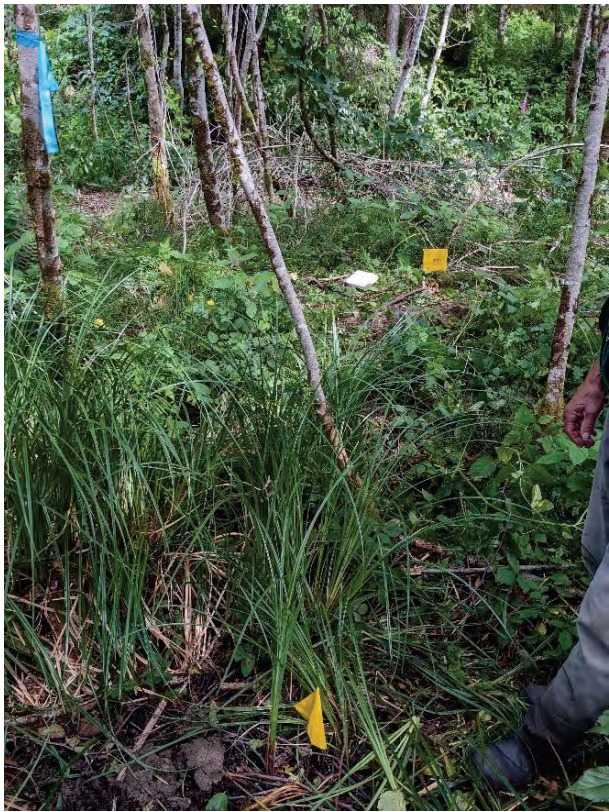
Figure 1. Looking east from SP-2 (wetland) in the foreground to SP-1 in the background. SP2 is within Jackson Street ROW (P-1).

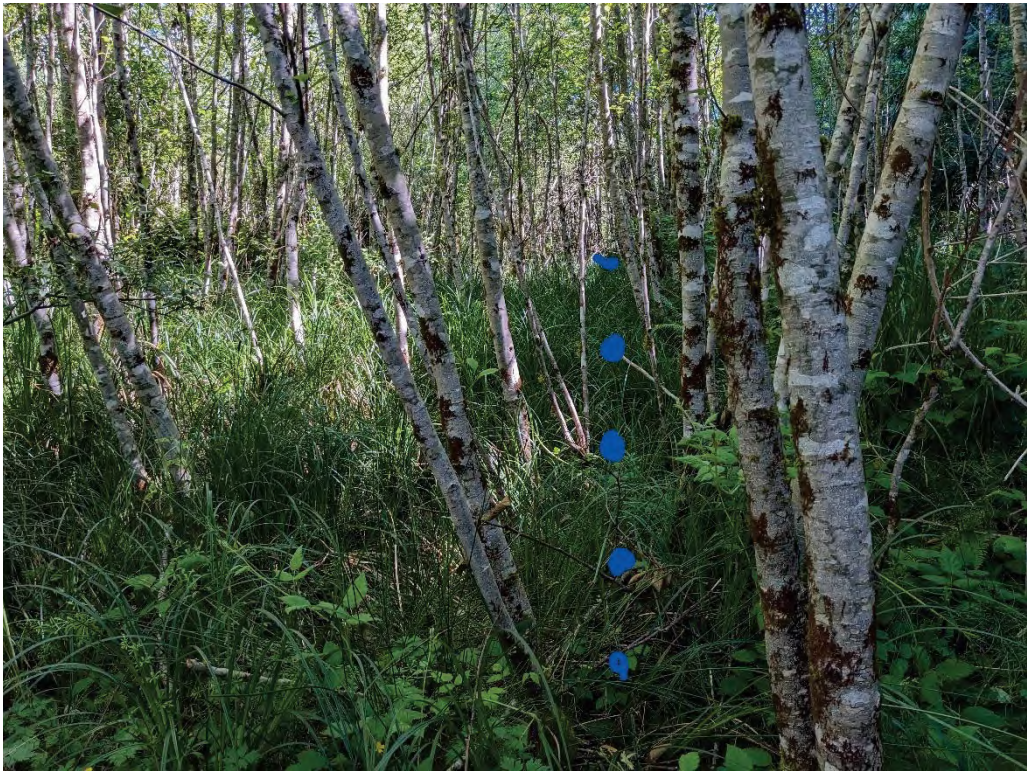
Figure 2. Jackson Street on left of blue dotted line and non-wetland on right looking north (P-2).

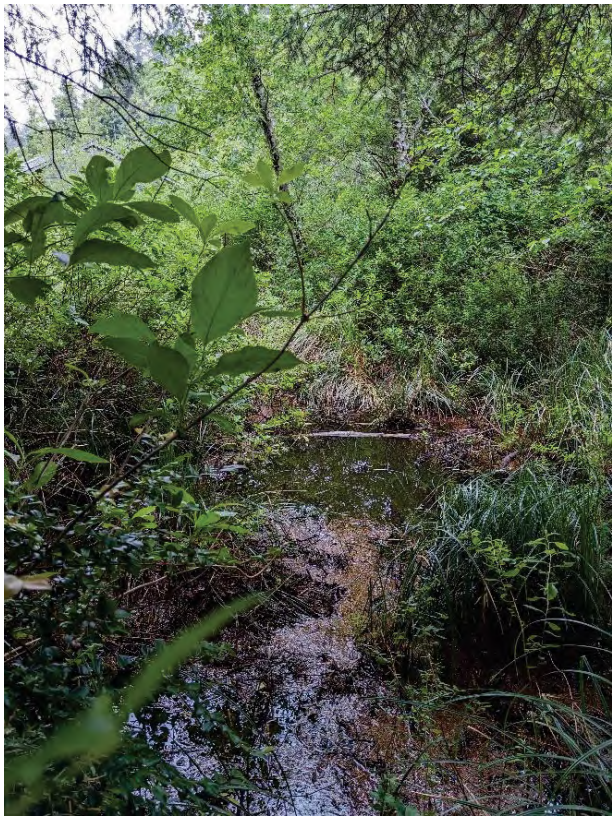
Figure 3. Looking east into wetland from SP 6. Elevated water levels are from restricted flow at culvert crossing at Kittiwake Drive. June 21, 2024 (P-3)

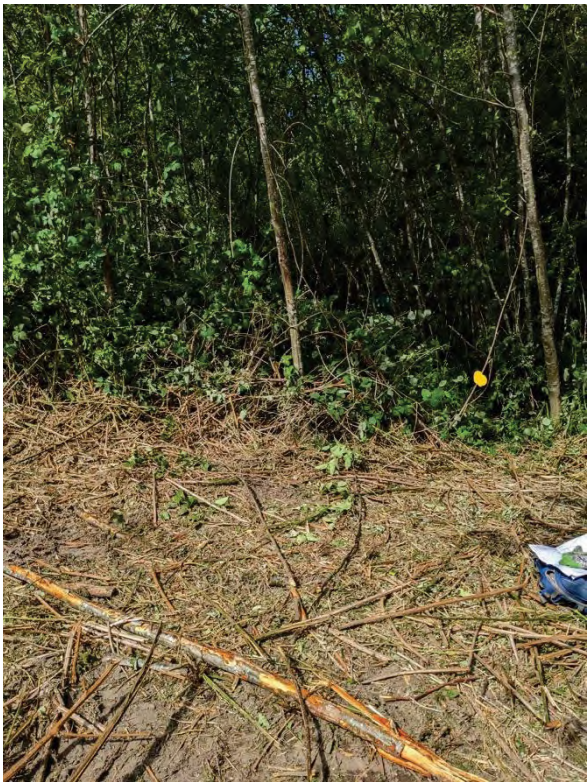
Figure 4. Lot 23 looking northeast from edge of fell at SP-3 non-wetland (yellow dot.) Kurt is in the background at SP-4. (P-4)

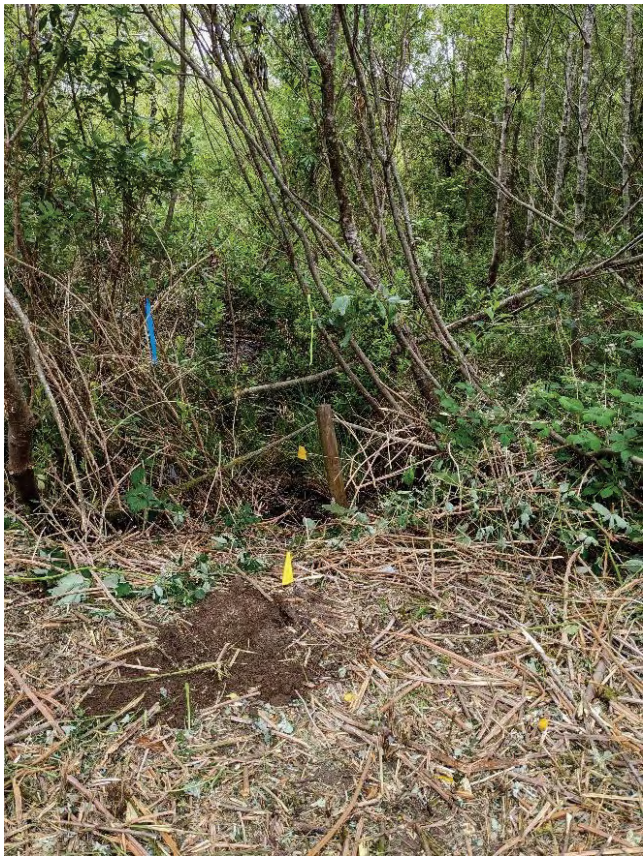
Figure 5. SP 9 in foreground looking south into wetland at SP 8 background. Blue flag is the wetland boundary. (P-5)

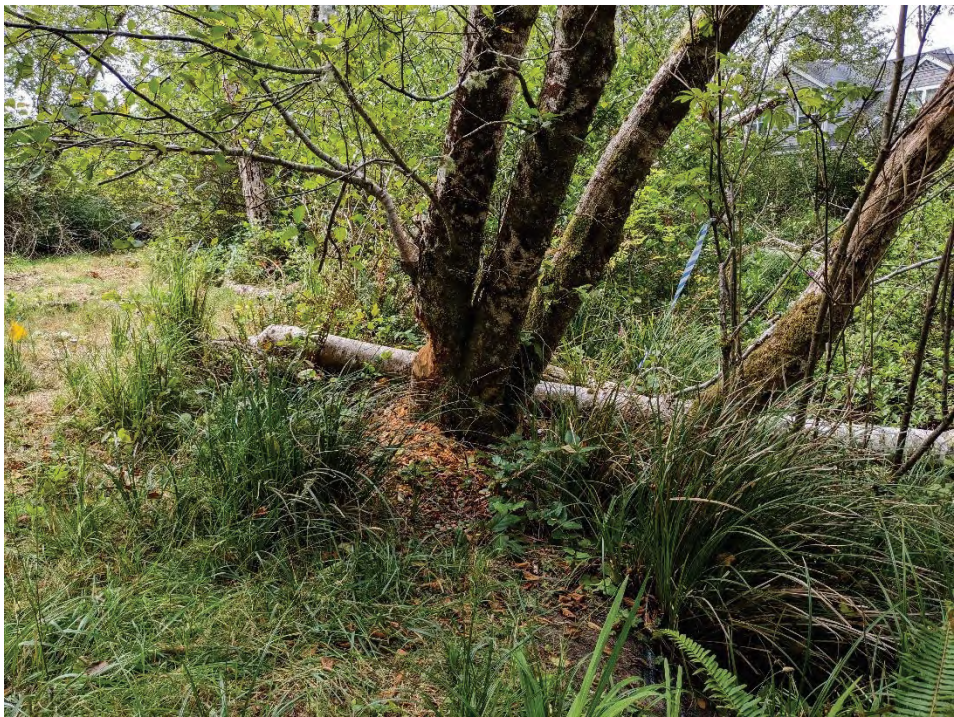
Figure 6. Lot 10200-Left-Yellow pin flag at SP-12. Right-Blue Stripe falling at OHWL-12 looking south. Filled wetland in the background. Beaver activity along McMillan Creek. August 12, 2024 (P-6)

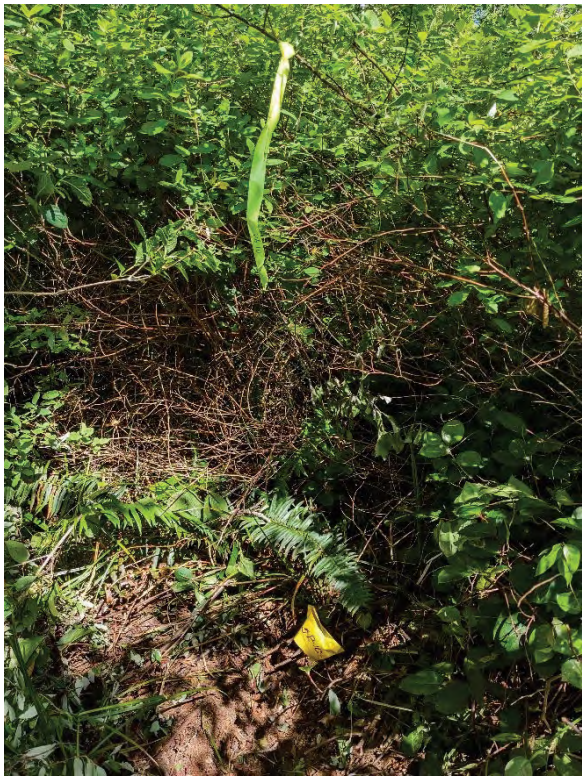
Figure 7. SP-10 looking north into non-wetland. (P-7)

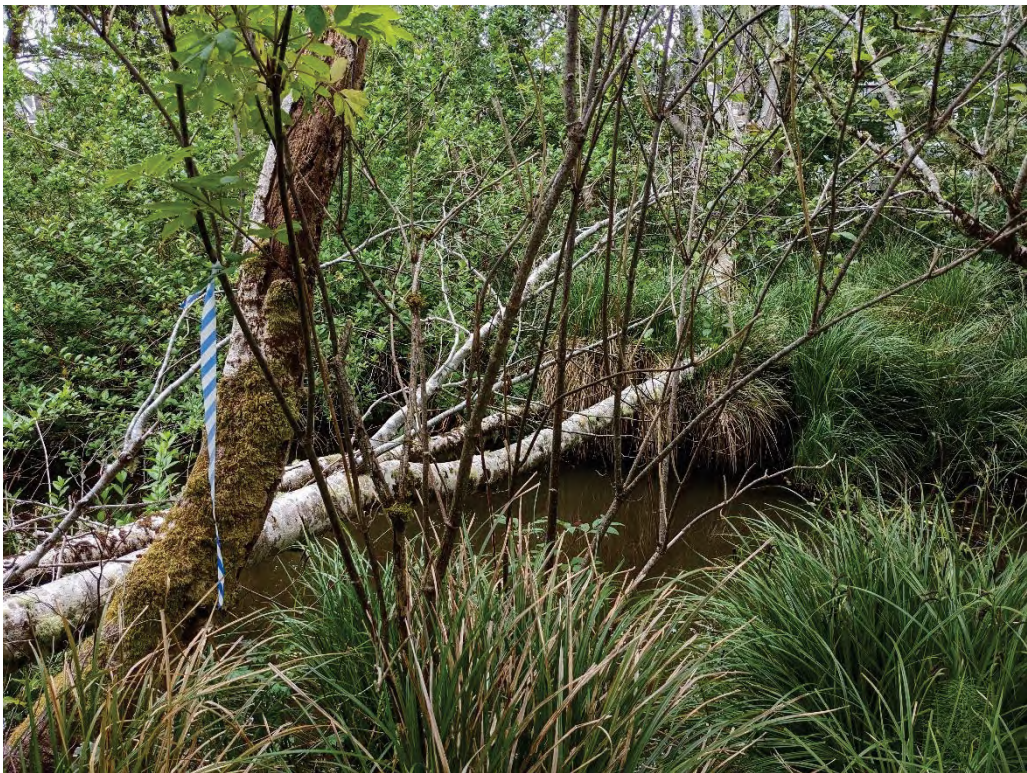
Figure 8. Looking west into McMillan Creek from the top of the bank. (P-8)

The top of the bank was used to demarcate the **OHWL R1** along McMillan Creek and S1. Water flow is slow moving as McMillan Creek flows across an incised low gradient floodplain. Stream substrate is sandy. Channel width is more than 20 feet and channel depth are 3-6 feet. On the day of the site visit in June the water depth was 16- 20 + inches. The banks are vegetated with Red Alder, Black Twinberry, Salal, Salmonberry, Red Elderberry, Slough Sedge and Sword Fern. Flow is perennial. Woody debris is abundant. Beaver activity is present although no dams were observed within the main channel. Fish presence is unknown.

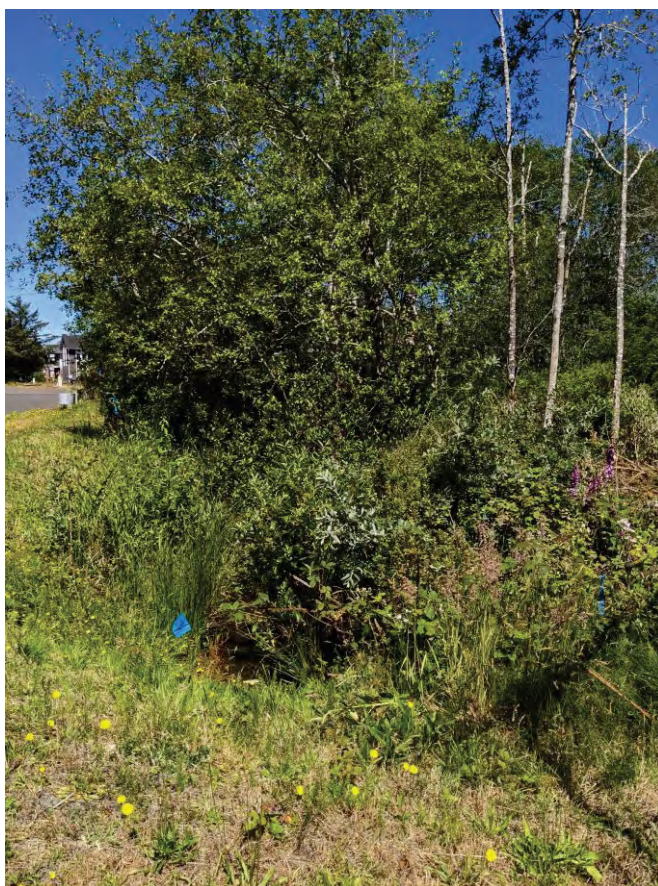
Figure 9. Riley Street to the left of unnamed stream OHWL (blue flag). Photo taken from the edge of Kittiwake Drive looking west. (P-9)

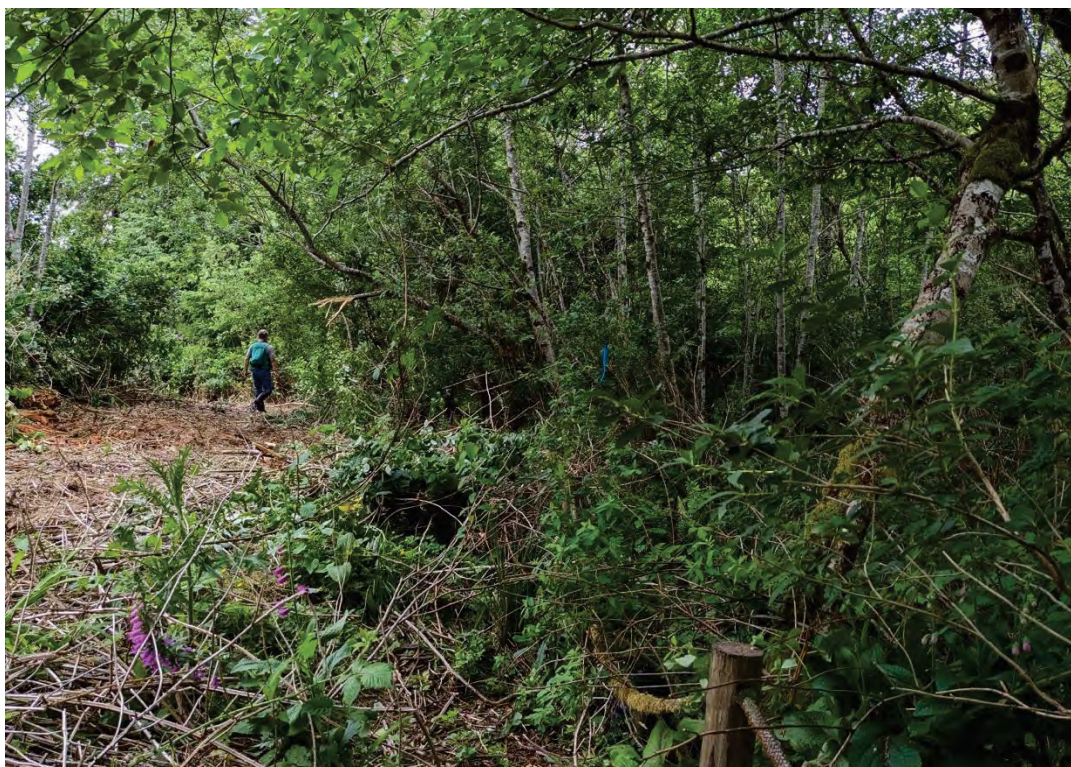
Figure 10. Corner of lot 17 looking north along the edge of fill (left) and wetland (right). P-10

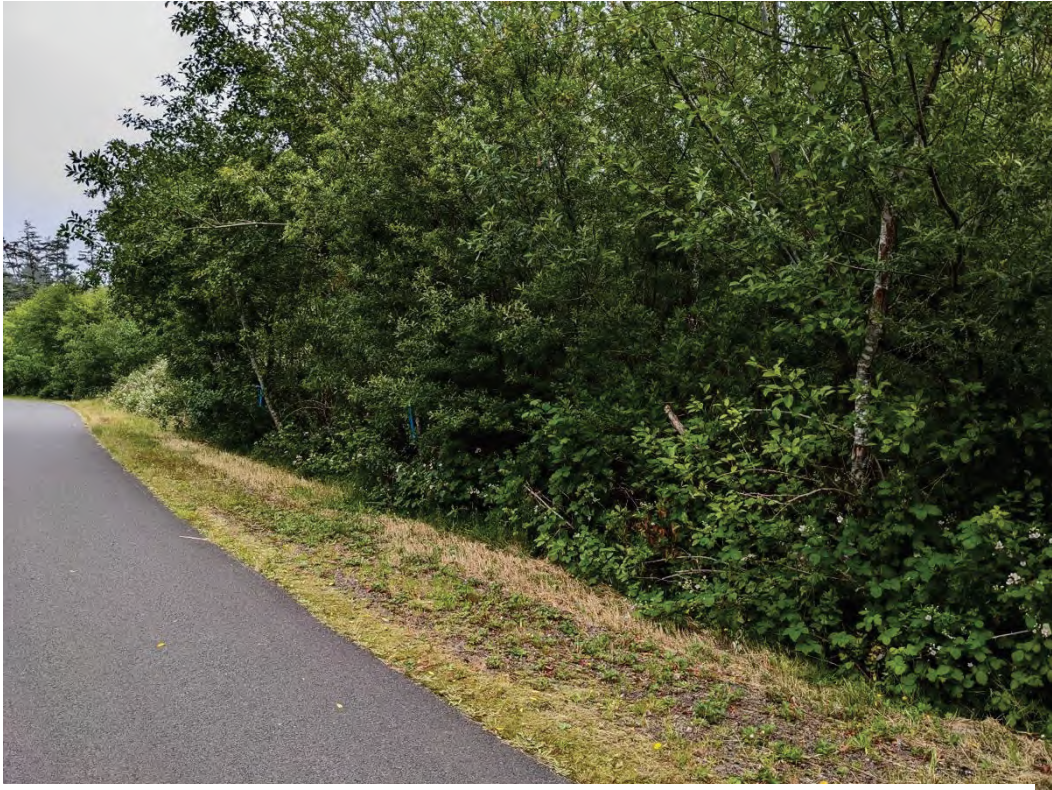
Figure 11. Edge of Kittiwake Drive looking northeast into wetland. (P-11)

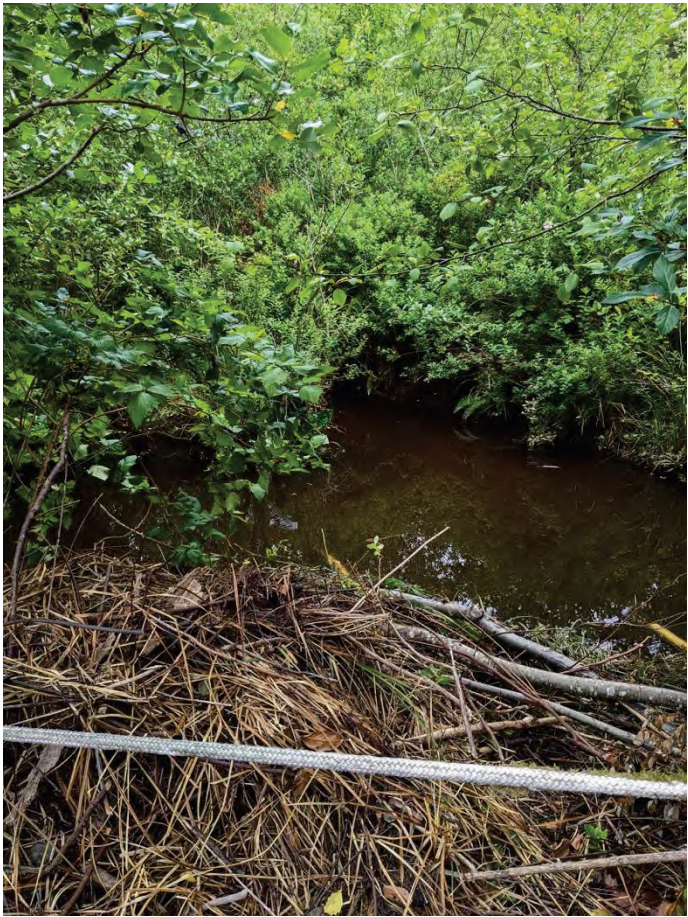
Figure 12. Beaver activity us of culvert crossing on Kittiwake Drive looking east into unnamed stream. June 20, 2024 (P-12)

Backflow of waters by beaver damming within the depression have created surface water and a high-water table for extended periods. Surface water levels were concentrated to the north on the day of the site visit. Soil indicators within the upper six inches of soil met the Sandy Mucky (S1) or Sandy Redox (S5) classification. Overstory vegetation is composed of young Red Alder and Hookers Willow with a dominance of Slough Sedge in the herbaceous layer. A wetland was identified in the wetland delineation and the mitigated fill plan by Rorick (2007). This study found that the proposed fill had been placed in 67% of the wetland, before the road was constructed. The remaining 33% are within the Jackson Street ROW.

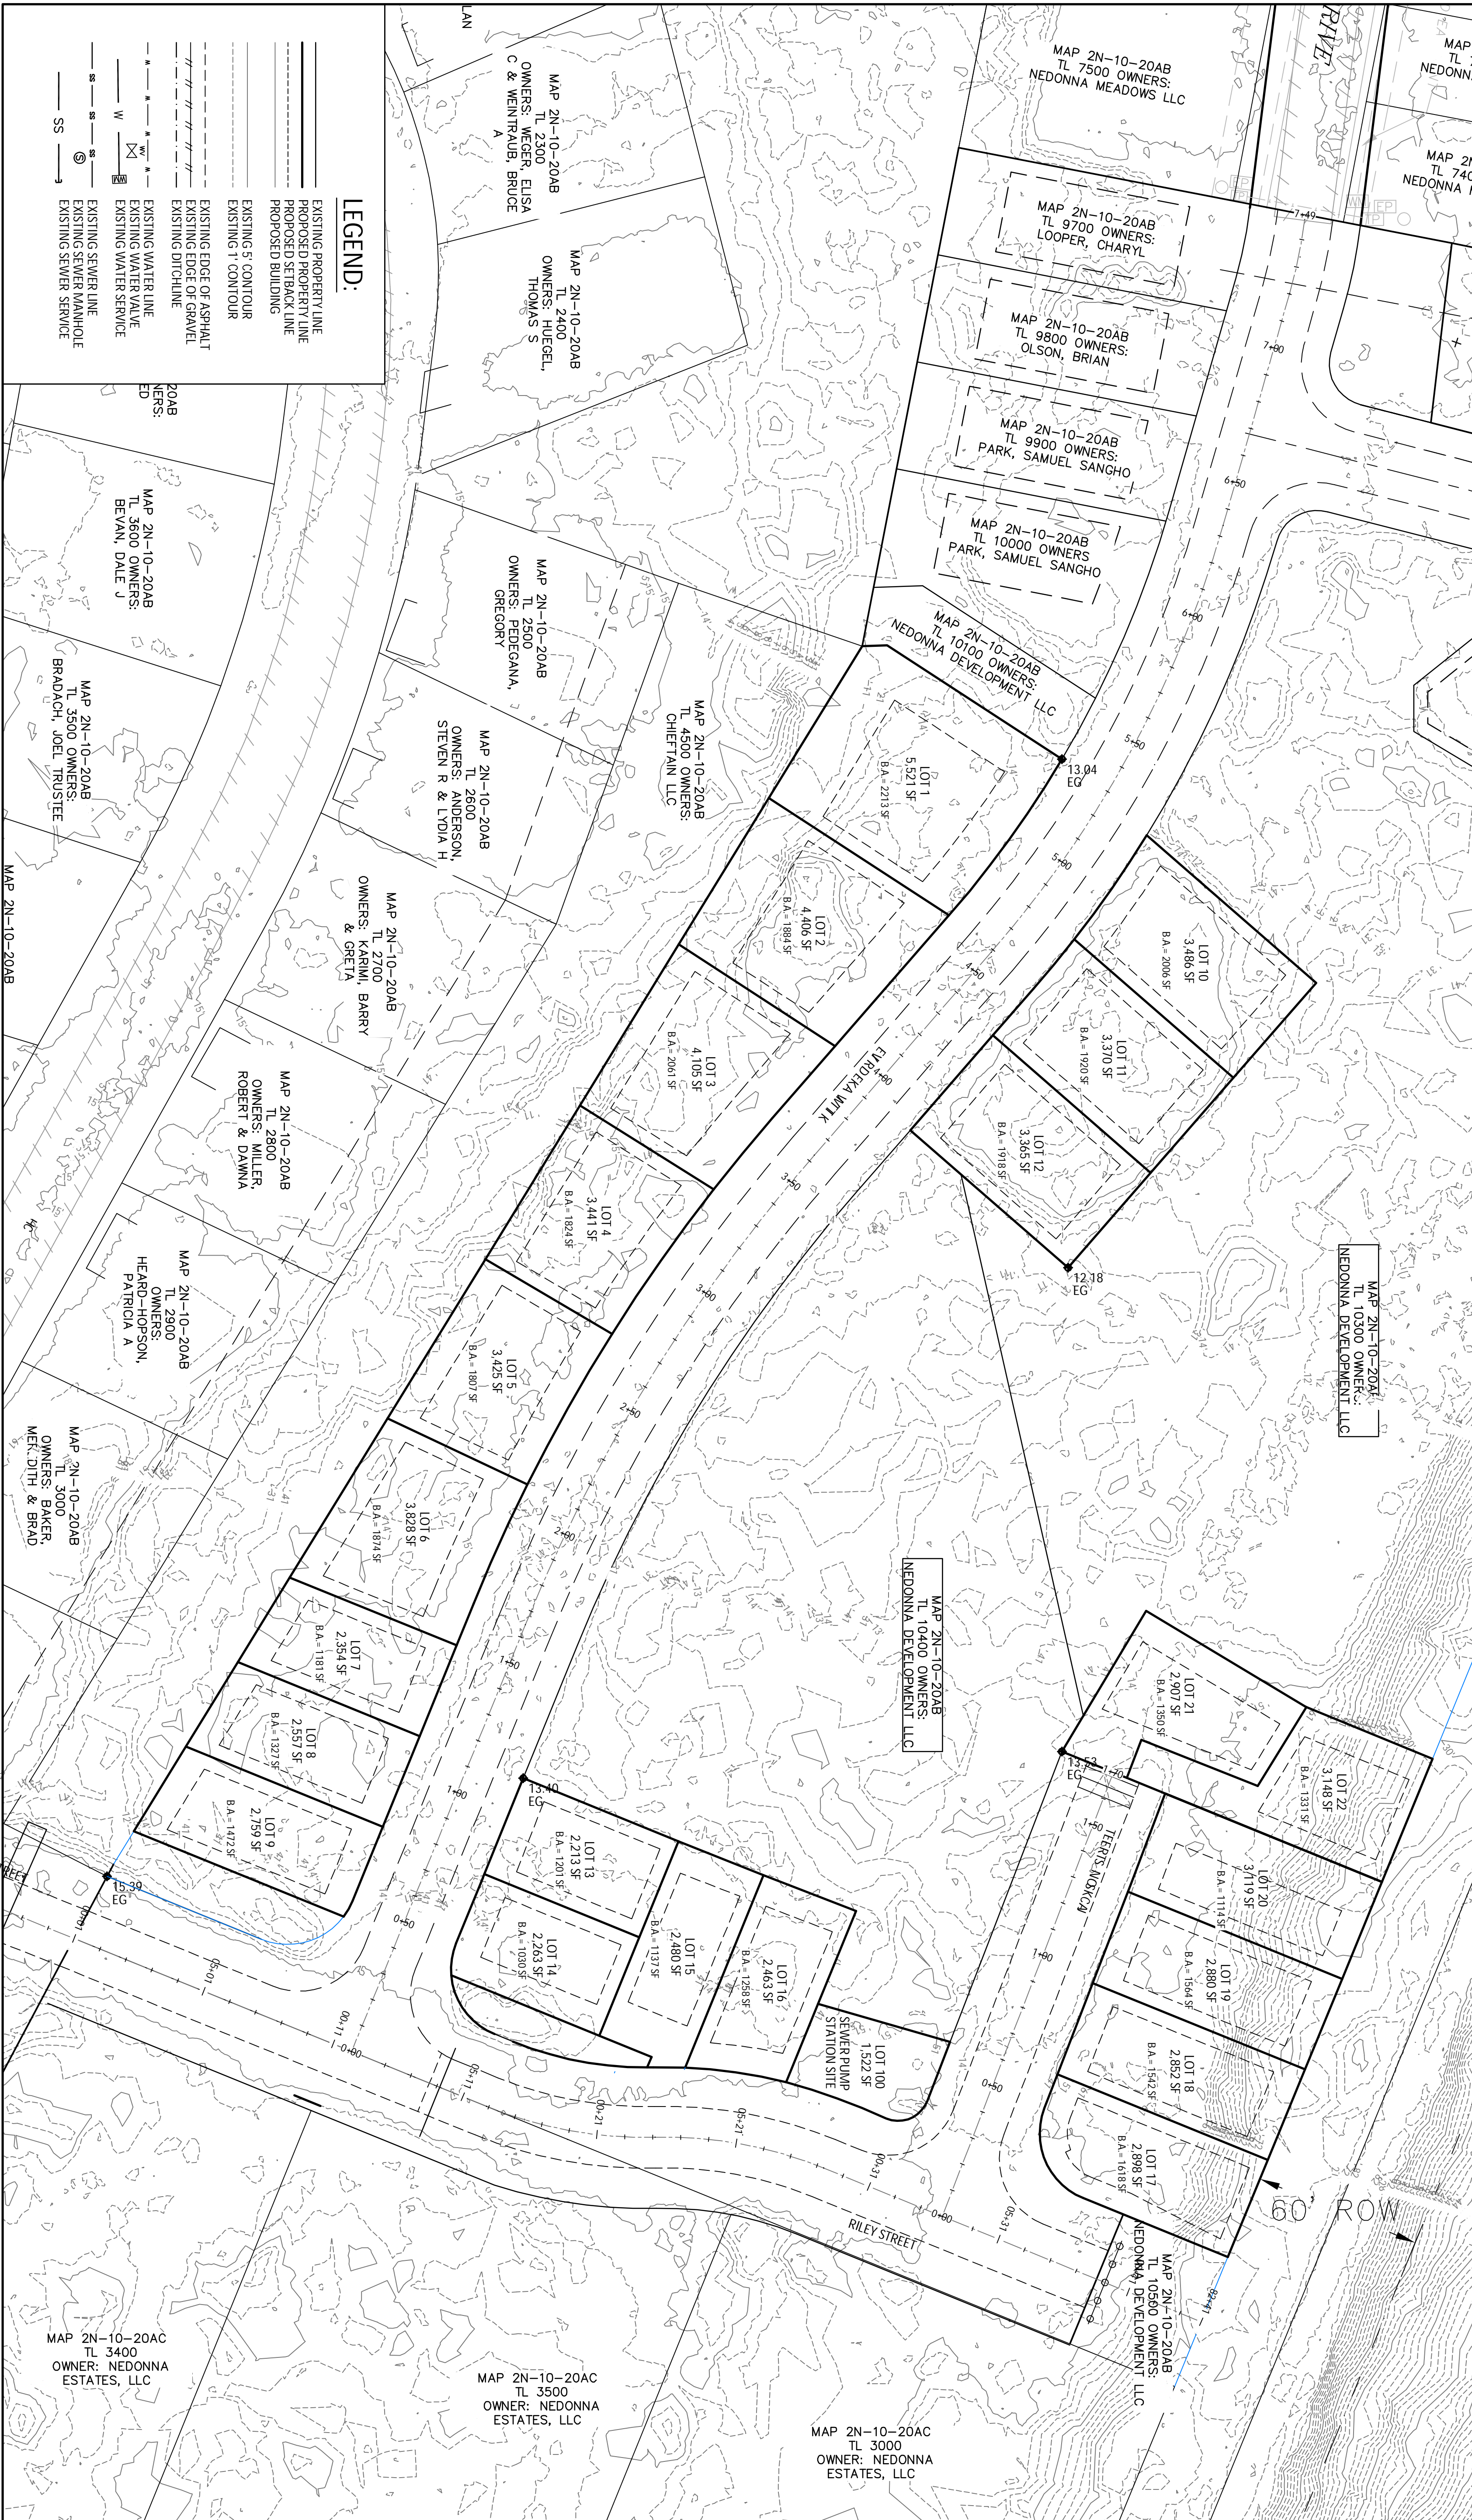
NEDONNA DEVELOPMENT, LLC  
NEDONNA WAVE - PHASE 2  
LOT LAYOUT

1  
2  
PROPOSED LOT LAYOUT  
SCALE: 1"=30'

NOTES:  
NO NEW STREETS ARE PROPOSED.  
ALL STREETS SHOWN ON THE PLAN ARE EXISTING.  
ELEVATIONS BASED ON 2008 DOGAMI LIDAR  
PROGRAM: NANTD08 DATUM.
