CITY OF ROCKAWAY BEACH SOUTH CORAL STREET STORMWATER FEASIBILITY STUDY

February 2024

Stormwater Feasibility Study

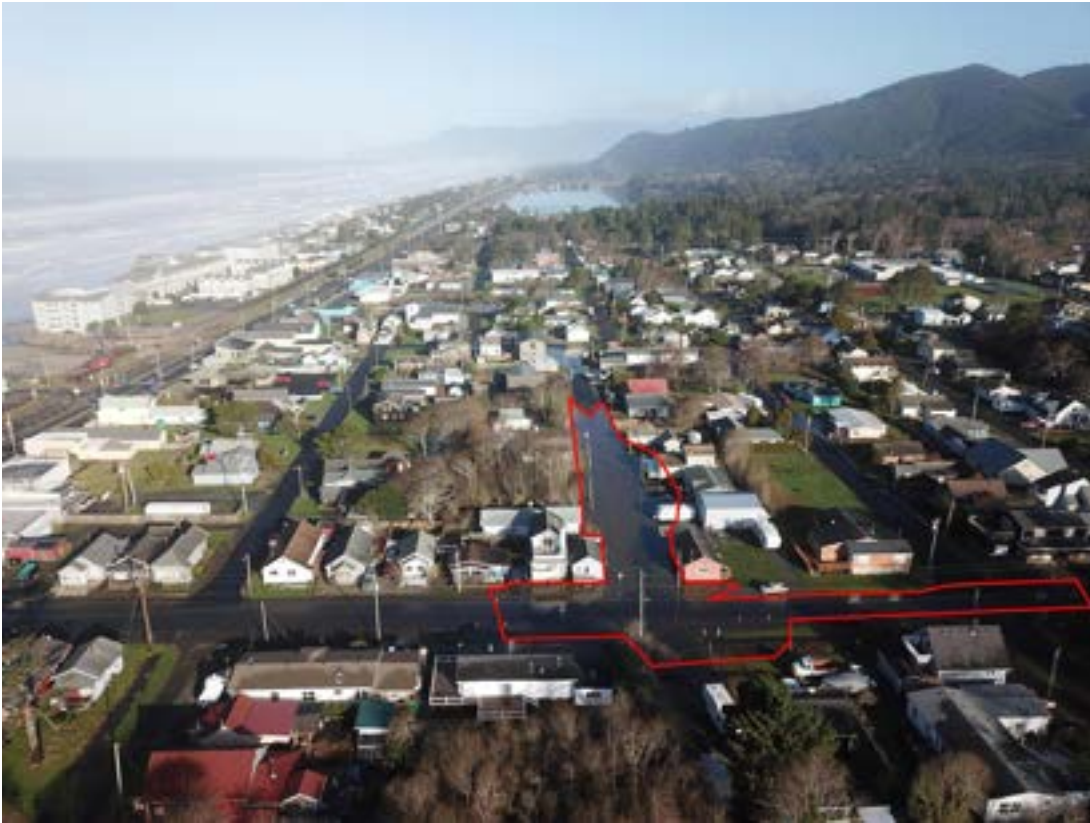
Figure 1 – Approximate Extents of January 2021 Flooding (drone photo by Bill Hassell)

The study area consists of South Coral Street from South Nehalem Avenue to South 2nd Avenue, the intersection of South 2nd Avenue and South Coral Street, and the South Beacon Street drainage channel flowing to Clear Lake. The area experiencing routine flooding is a low-lying area within the city and the storm drainage needs upgrades to more efficiently drain the right-of-way. Flooding is not contained to the right-of-way, as it flows onto private property in some areas. Figure 1 below shows drone footage captured by Bill Hassell during flooding in January 2021. The time stamp on the drone photo was cross-referenced with tide data to figure out the approximate elevation of flooding.

The cause of the flooding is due to the low-lying area at the intersection of South Second Avenue and South Coral Street receiving high amounts of runoff from the hills to the east along with high tide events backing up into pipes, preventing drainage.

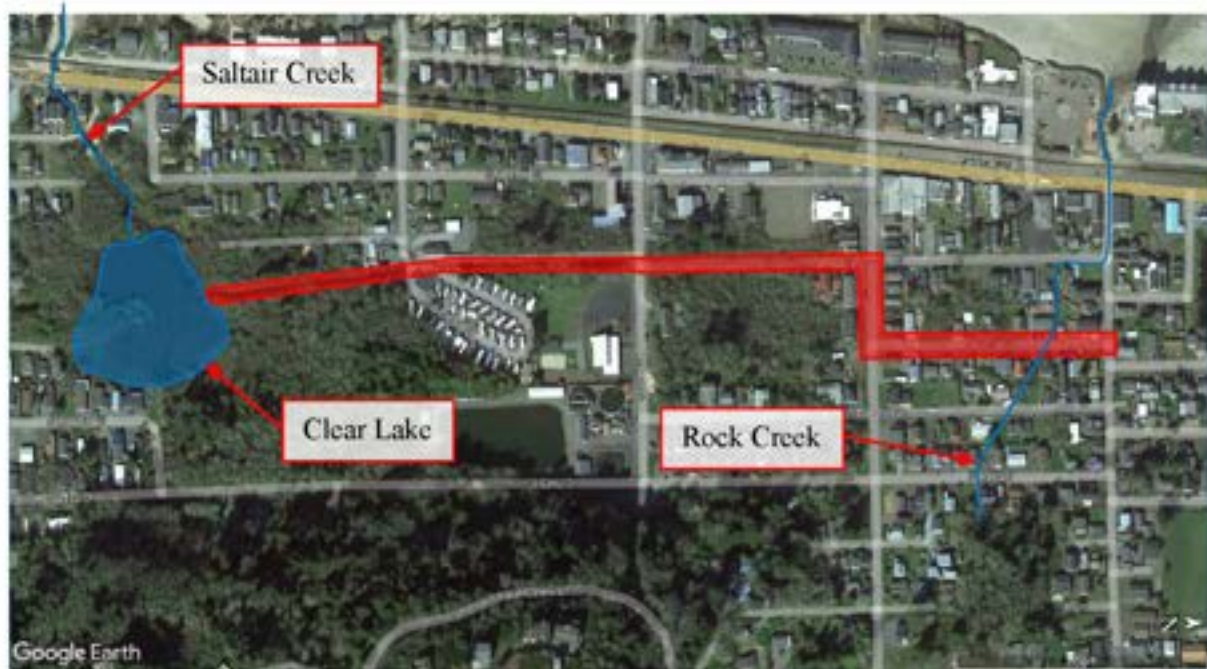
Figure 2 – Extents of Study Area

Starting at the north end of the drainage network on South Coral Street, north of Rock Creek near S Nehalem Avenue, there are a few catch basins that drain stormwater to the north. This stormwater network was not analyzed as a part of this study. The study area is shown in Figure 2.

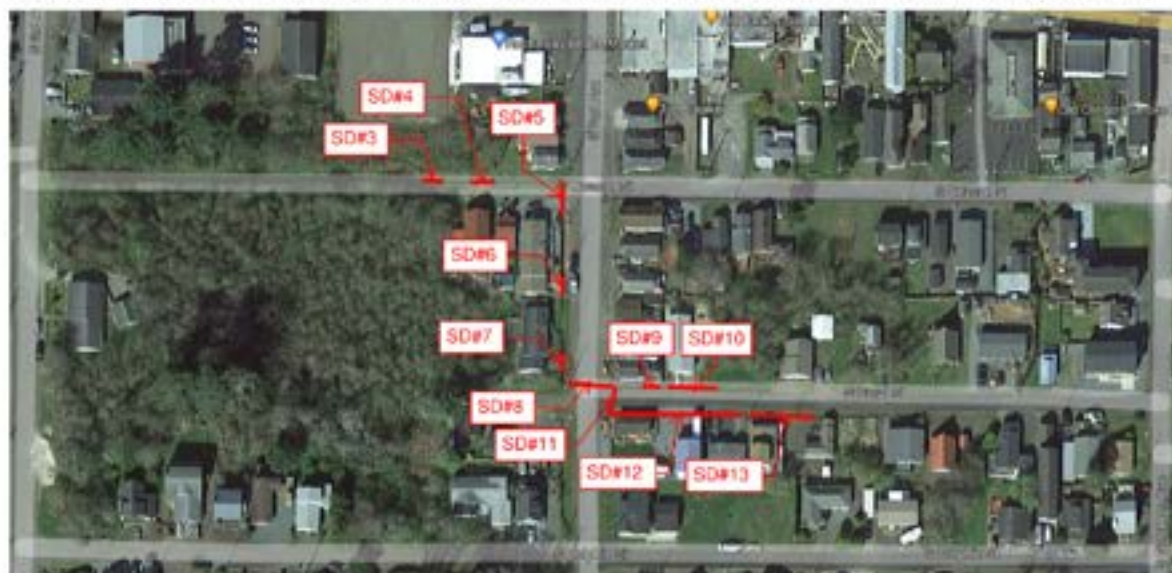
Figure 3 – Study Area Drainage Features

The study area starts on South Coral Street, just south of Rock Creek, where stormwater runs to the gravel/grassy shoulder of the road with very shallow channels on either side of the road that flow south. The channel on the east side of the street enters a 10" concrete culvert (SD #13, 72' @ 0.89% slope) approximately 200' south of Rock Creek. The concrete culvert has minimal cover over the pipe and runs to a small ditch in between two properties. The runoff enters another 12" concrete culvert (SD #12, 159' @ -0.18% slope) that is connected to a catch basin located in a driveway. This 12" culvert has reverse slope, meaning stormwater is detained upstream of the culvert until the water rises enough to overflow out the downstream end of the culvert. From here, stormwater continues before reaching its point of discharge into a catch basin at the northeast corner of the intersection of S Coral Street and S Second Avenue. Stormwater leaves the catch basin through a 10" concrete culvert (SD #11, 33' @ 0.42% slope) to the west which crosses the road and outfalls into the primary Beacon Street drainage network. These drainage features are shown in Figure 3 and again in Appendix A.

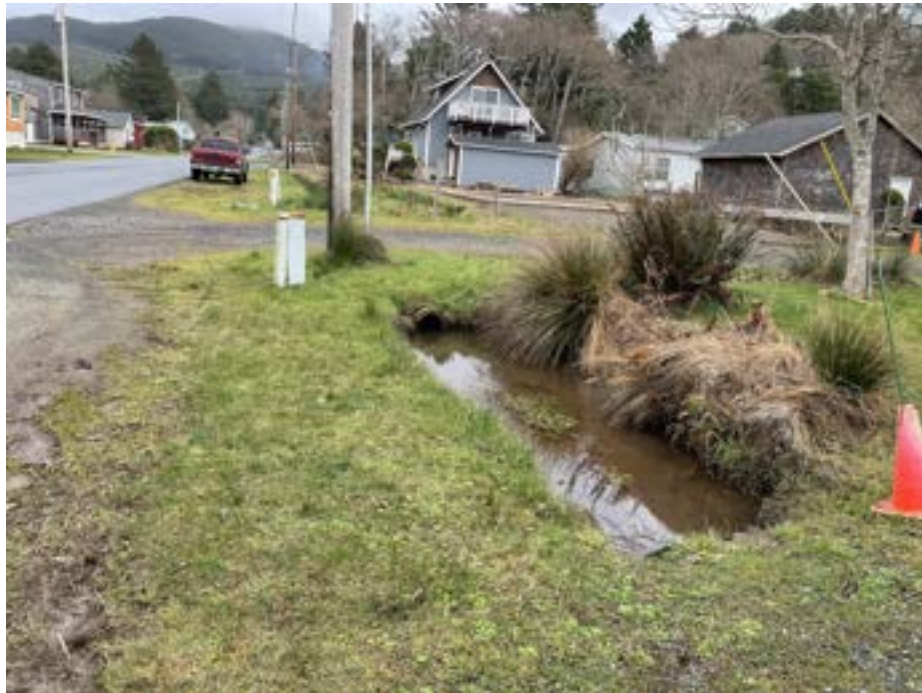
Figure 4 – Drainage Ditch on the South Side of the S 2nd Ave & S Coral St Intersection

Stormwater from S Coral Street runs to the ditch at the northwest corner of the intersection of South Coral Street and South Second Avenue before entering a 10" stormwater pipe (SD #8, 57' @ -0.35%) to cross to the south side of S Second Avenue and outfall into the roadside ditch. This pipe also has reverse slope. Runoff then enters the roadside ditch on the south side of S Second Street and runs west through a series of culverts under residential driveways before reaching a culvert running under S Beacon Street. This stretch of roadside ditch also flows backward with an Invert Elevation (IE) of 13.75' on the east side to 13.85' on the west side. This will cause water to pool in the ditch all year round if the soil does not drain the water as seen in Figure 4 (picture taken 02/2023).

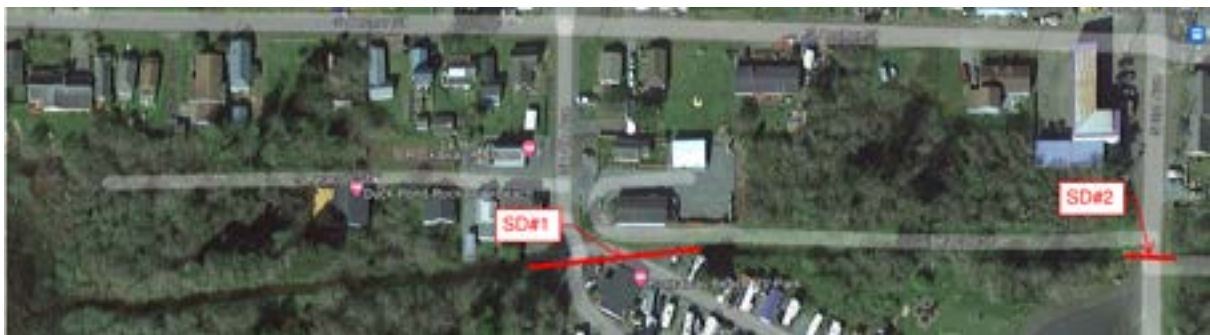
Figure 5 – Culvert Location Map

Table 1 lists details for culverts in the study area. Figures 5 and 6 show culverts within the study area.

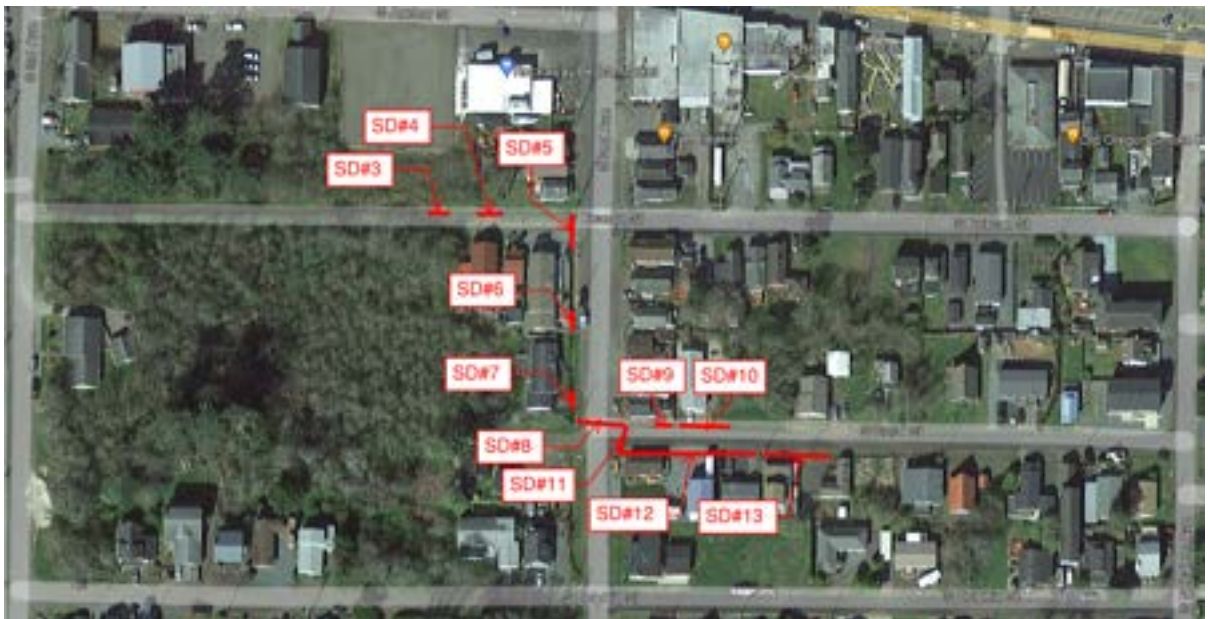
Figure 6 – Culvert Location Map

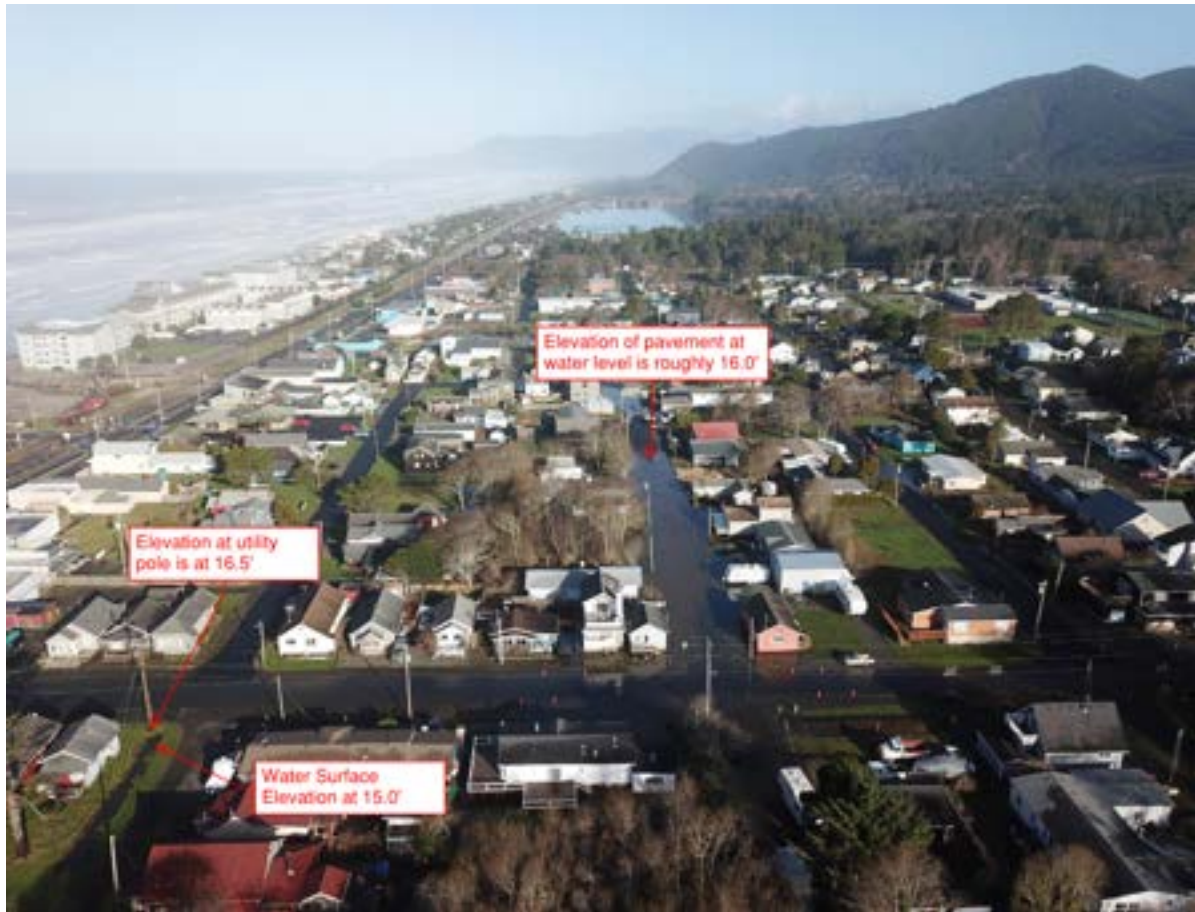
Figure 7 – Water Surface Elevation During Flooding

The second issue is the lack of consistent fall through the drainage network. There is adequate elevation change from the north end of Coral St to Clear Lake; however, in between, the pipe network zig-zags up and down, not allowing runoff to drain completely after each rain event. This causes water to pool in the storm network up to elevation 14.01 ft where the biggest hump in the network is reducing any storage downstream for the next rain event.

The final item that should be considered is the upsizing of the culverts on S 2nd Avenue between S Beacon Street and S Coral Street. These culverts are identified in this report as SD #5-8. In reviewing the aerial drone footage during a flood, it appears the flood waters on S Coral Street are up to an approximate 16 ft elevation. However, in the same photo, the water level in the S Beacon Street channel appears to be approximately one foot below the guy wires from the utility pole at the intersection of S 2nd Avenue and S Beacon Street. This would imply a water surface level of 14.5 ft. The 1.5 ft difference in elevation of flood waters is extremely unusual and would imply a potential blockage in one or more of the culverts SD #5-8. Smaller culverts, particularly SD #8 (10" diameter) will have a higher probability of being plugged with debris that has been transported through the ditch network. Once a culvert becomes plugged, the upstream collection system is effectively cut off from the downstream system, which can cause flooding where insufficient detention exists. Upsizing these culverts to a minimum of 24" in diameter will reduce the risk of the culverts being plugged. Additionally, once flood waters begin moving, drainage to the S Beacon Street channel network would be more rapid. Table 3 below shows a cost breakdown of improvements to the S Beacon Street channel network. It assumes a total of 30,000 cubic yards (CY) of material will be removed from the channels. Planning level costs are provided in Table 3 under the assumption the work is completed by a contractor under a public bid with prevailing wage rates.
