RESOLUTION NO. 2024-18

**CITY OF ROCKAWAY BEACH
SOUTH CORAL STREET
STORMWATER FEASIBILITY STUDY**

February 2024

H B H
CONSULTING
ENGINEERS

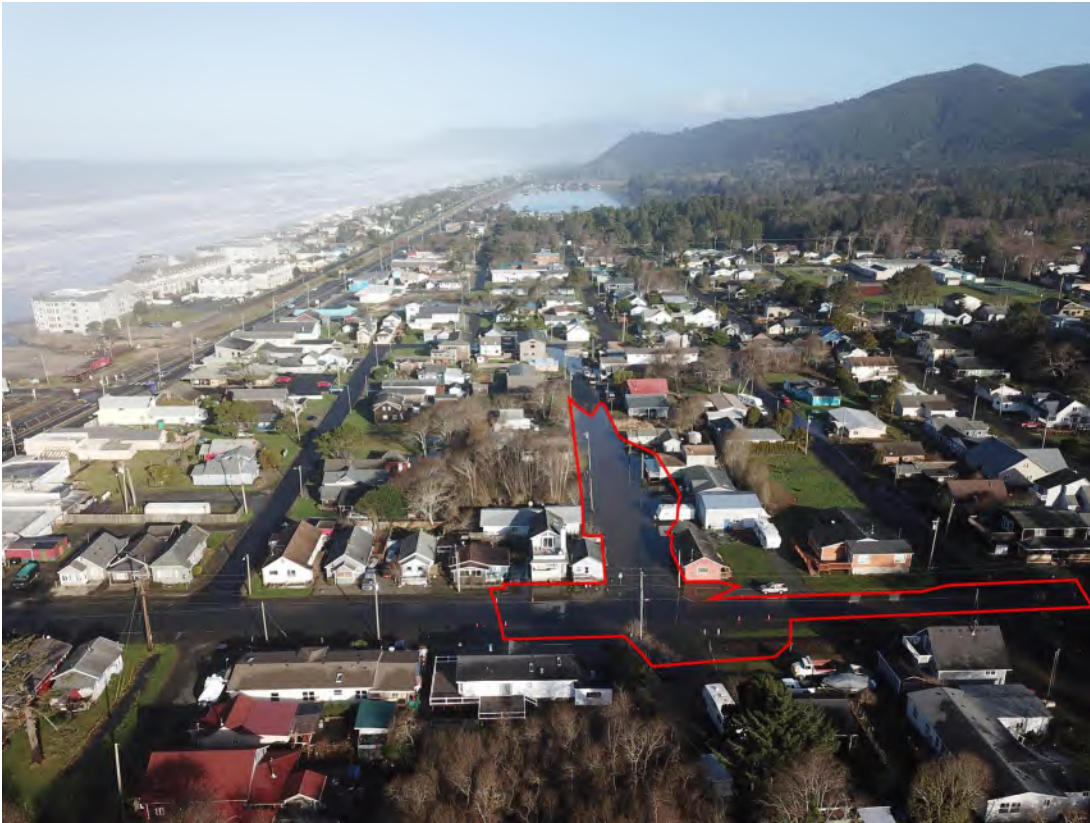
Figure 1 – Approximate Extents of January 2021 Flooding (drone photo by Bill Hassell)

The study area consists of South Coral Street from South Nehalem Avenue to South 2nd Avenue, the intersection of South 2nd Avenue and South Coral Street, and the South Beacon Street drainage channel flowing to Clear Lake. The area experiencing routine flooding is a low-lying area within the city and the storm drainage needs upgrades to more efficiently drain the right-of-way. Flooding is not contained to the right-of-way, as it flows onto private property in some areas. Figure 1 below shows drone footage captured by Bill Hassell during flooding in January 2021. The time stamp on the drone photo was cross-referenced with tide data to figure out the approximate elevation of flooding.

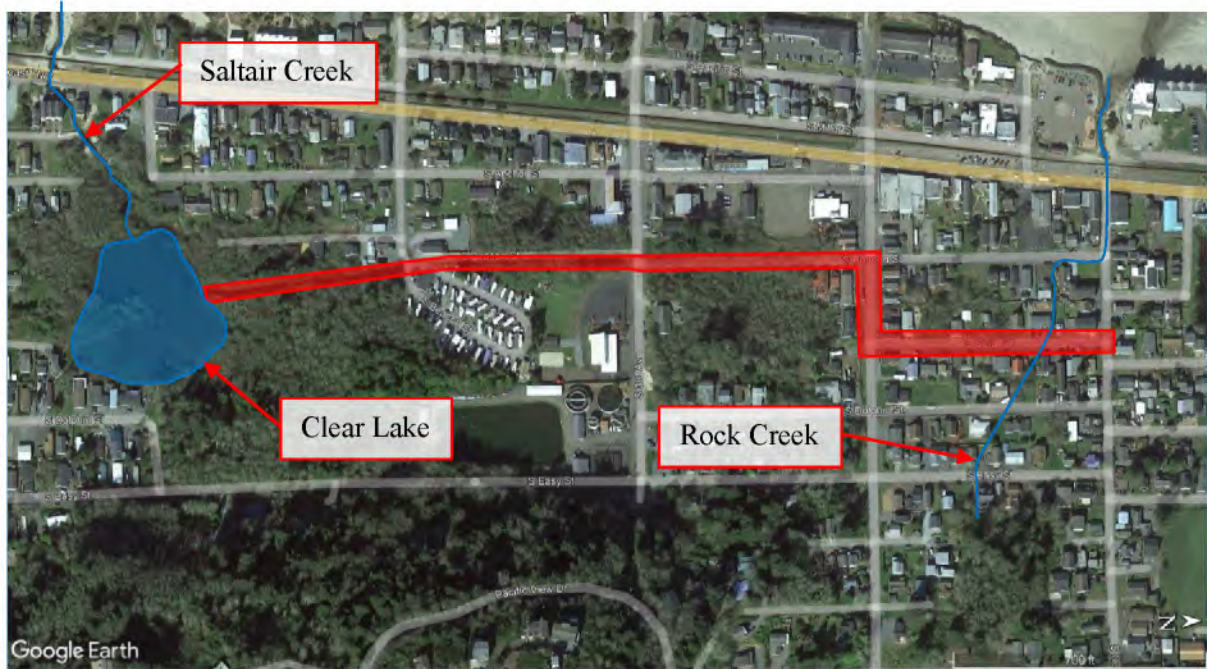
Figure 2 – Extents of Study Area

Starting at the north end of the drainage network on South Coral Street, north of Rock Creek near S Nehalem Avenue, there are a few catch basins that drain stormwater to the north. This stormwater network was not analyzed as a part of this study. The study area is shown in Figure 2.

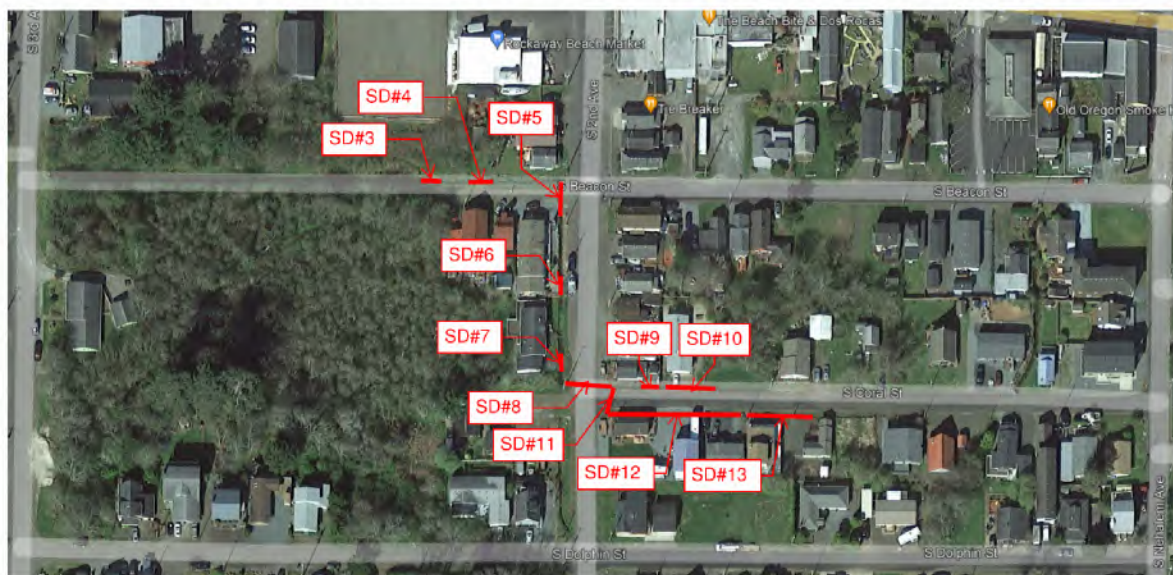
Figure 3 – Study Area Drainage Features

The study area starts on South Coral Street, just south of Rock Creek, where stormwater runs to the gravel/grassy shoulder of the road with very shallow channels on either side of the road that flow south. The channel on the east side of the street enters a 10” concrete culvert (SD #13, 72’ @ 0.89% slope) approximately 200’ south of Rock Creek. The concrete culvert has minimal cover over the pipe and runs to a small ditch in between two properties. The runoff enters another 12” concrete culvert (SD #12, 159’ @ -0.18% slope) that is connected to a catch basin located in a driveway. This 12” culvert has reverse slope, meaning stormwater is detained upstream of the culvert until the water rises enough to overflow out the downstream end of the culvert. From here, stormwater continues before reaching its point of discharge into a catch basin at the northeast corner of the intersection of S Coral Street and S Second Avenue. Stormwater leaves the catch basin through a 10” concrete culvert (SD #11, 33’ @ 0.42% slope) to the west which crosses the road and outfalls into the primary Beacon Street drainage network. These drainage features are shown in Figure 3 and again in Appendix A.

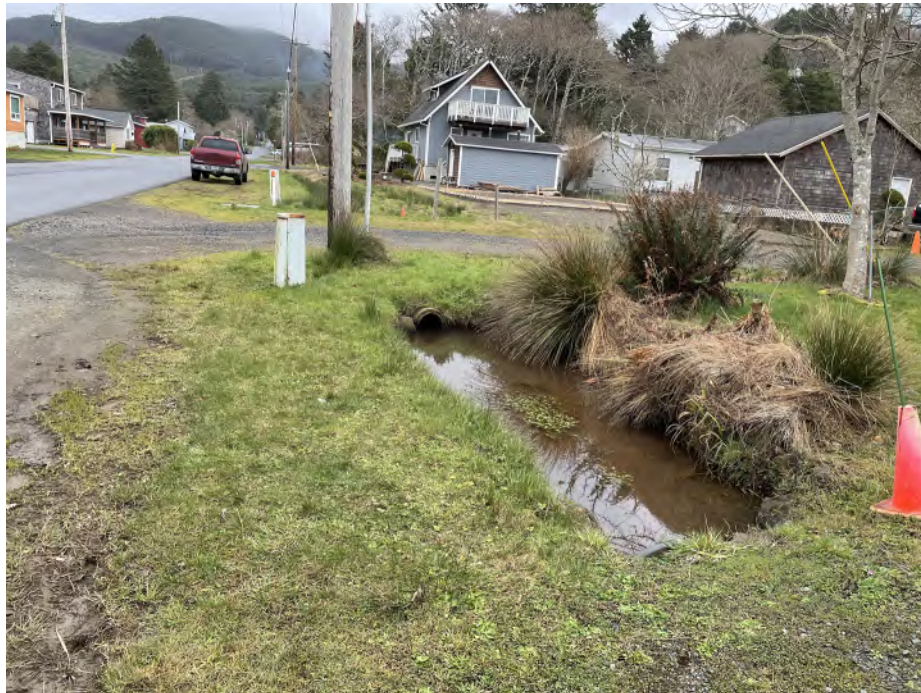
Figure 4 – Drainage Ditch on the South Side of the S 2nd Ave & S Coral St Intersection

Stormwater from S Coral Street runs to the ditch at the northwest corner of the intersection of South Coral Street and South Second Avenue before entering a 10" stormwater pipe (SD #8, 57' @ -0.35%) to cross to the south side of S Second Avenue and outfall into the roadside ditch. This pipe also has reverse slope. Runoff then enters the roadside ditch on the south side of S Second Street and runs west through a series of culverts under residential driveways before reaching a culvert running under S Beacon Street. This stretch of roadside ditch also flows backward with an Invert Elevation (IE) of 13.75' on the east side to 13.85' on the west side. This will cause water to pool in the ditch all year round if the soil does not drain the water as seen in Figure 4 (picture taken 02/2023).

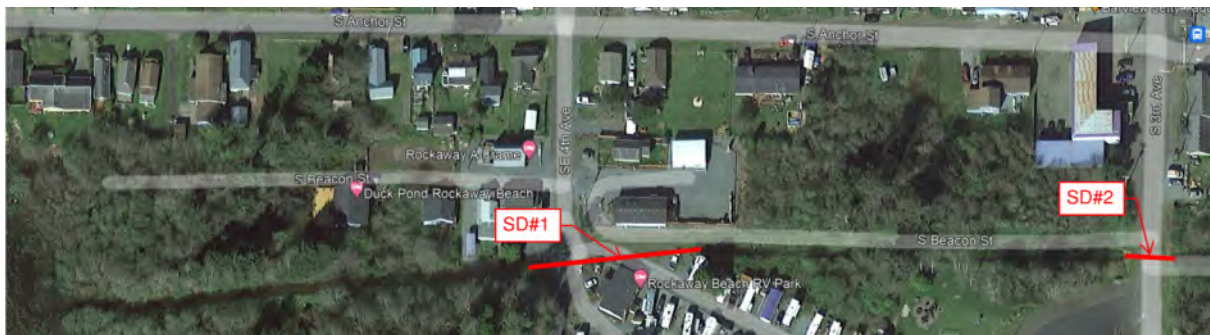
Figure 5 – Culvert Location Map

Table 1 lists details for culverts in the study area. Figures 5 and 6 show culverts within the study area.

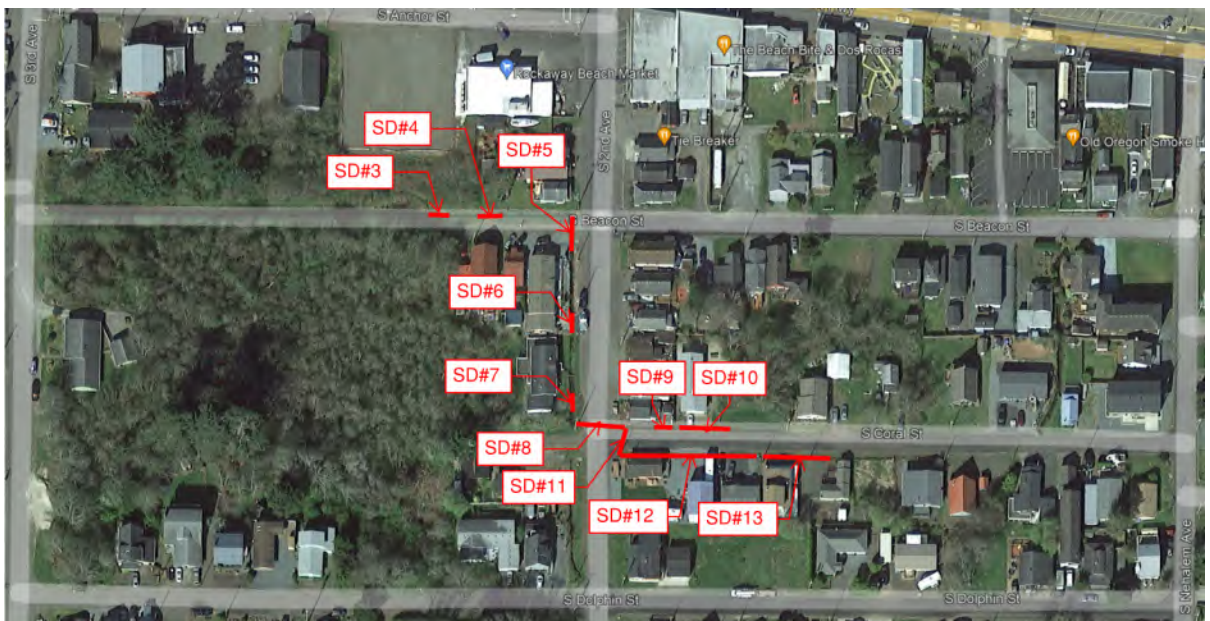
Figure 6 – Culvert Location Map

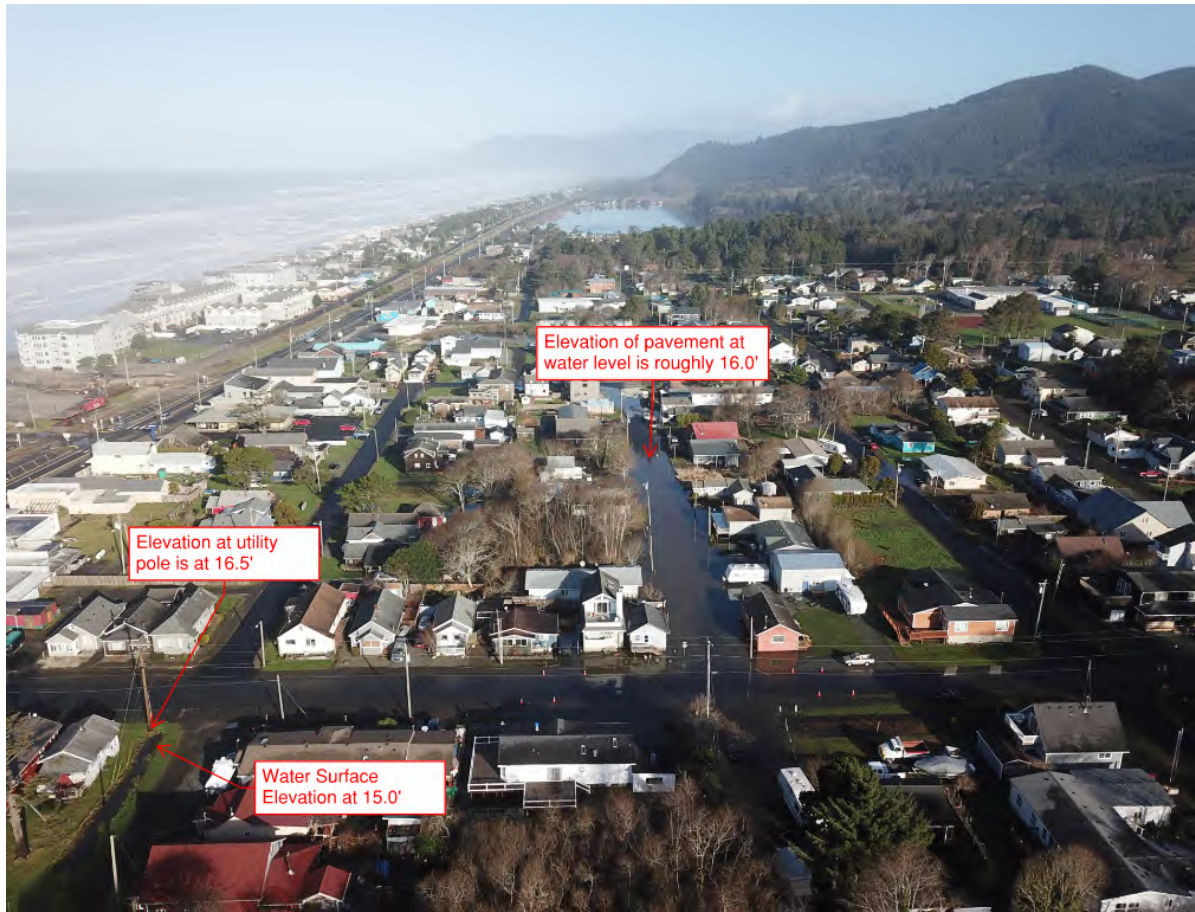
Figure 7 – Water Surface Elevation During Flooding

The second issue is the lack of consistent fall through the drainage network. There is adequate elevation change from the north end of Coral St to Clear Lake; however, in between, the pipe network zig-zags up and down, not allowing runoff to drain completely after each rain event. This causes water to pool in the storm network up to elevation 14.01 ft where the biggest hump in the network is reducing any storage downstream for the next rain event.

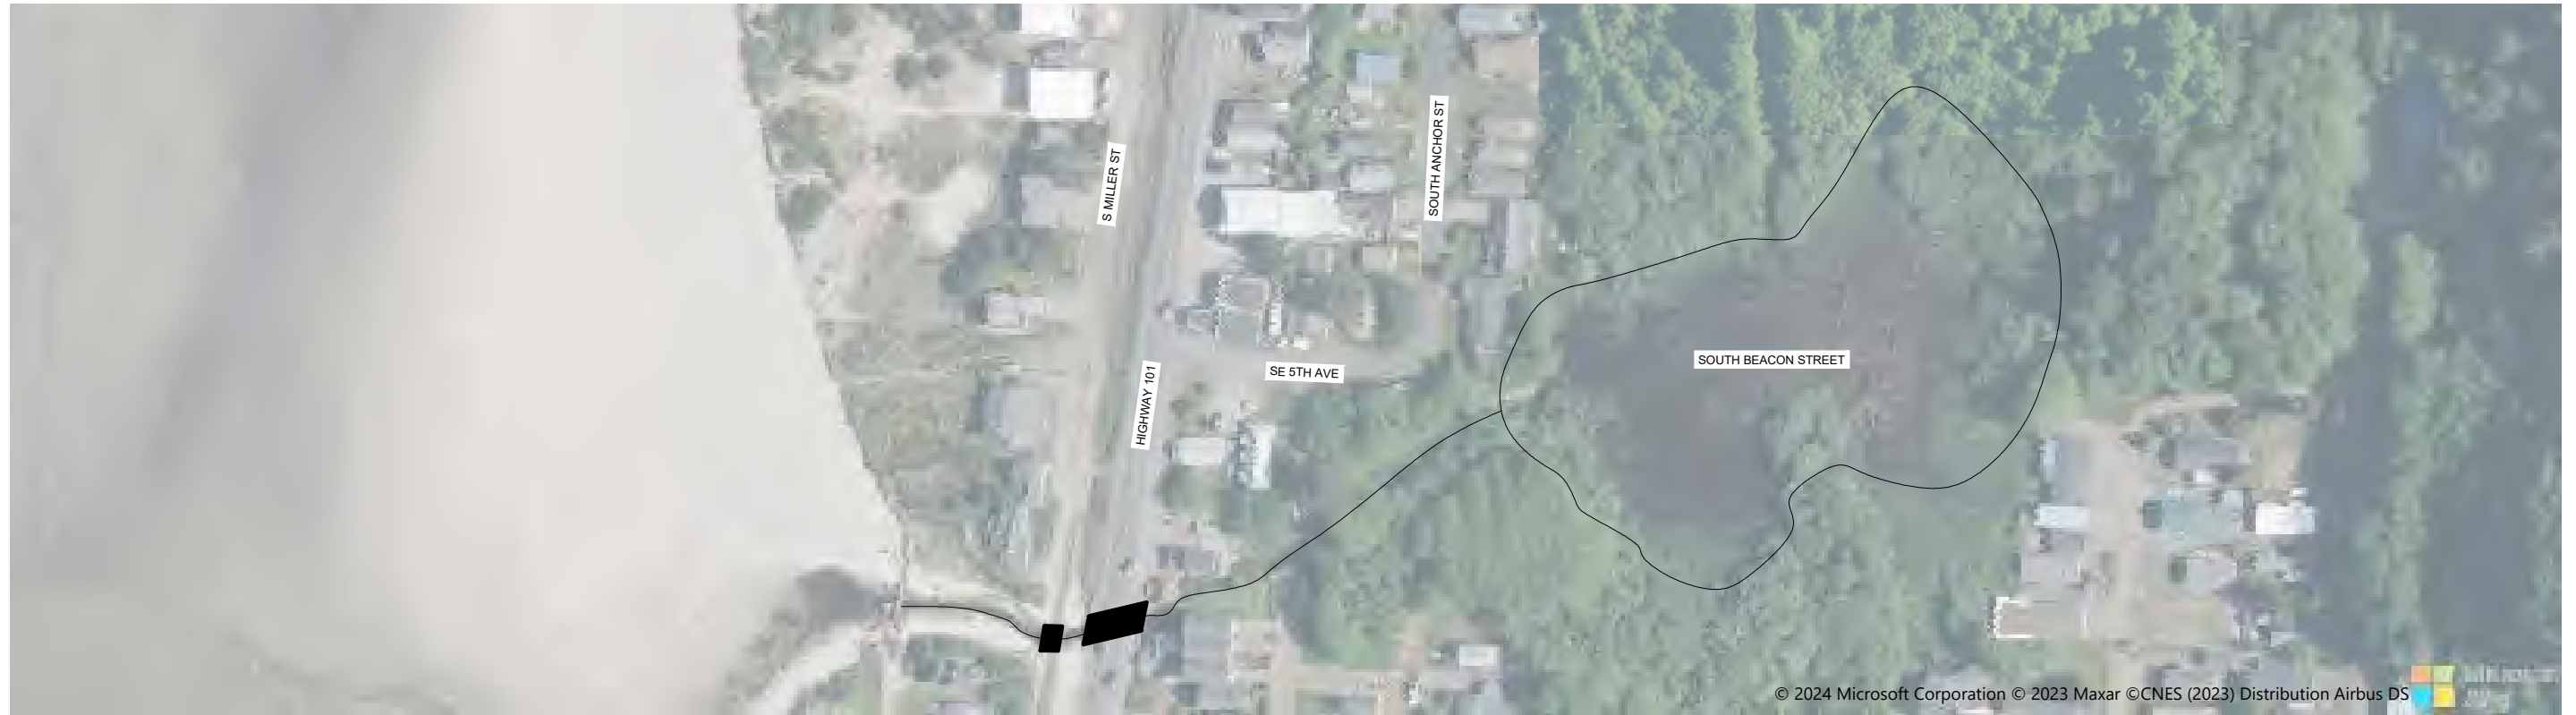
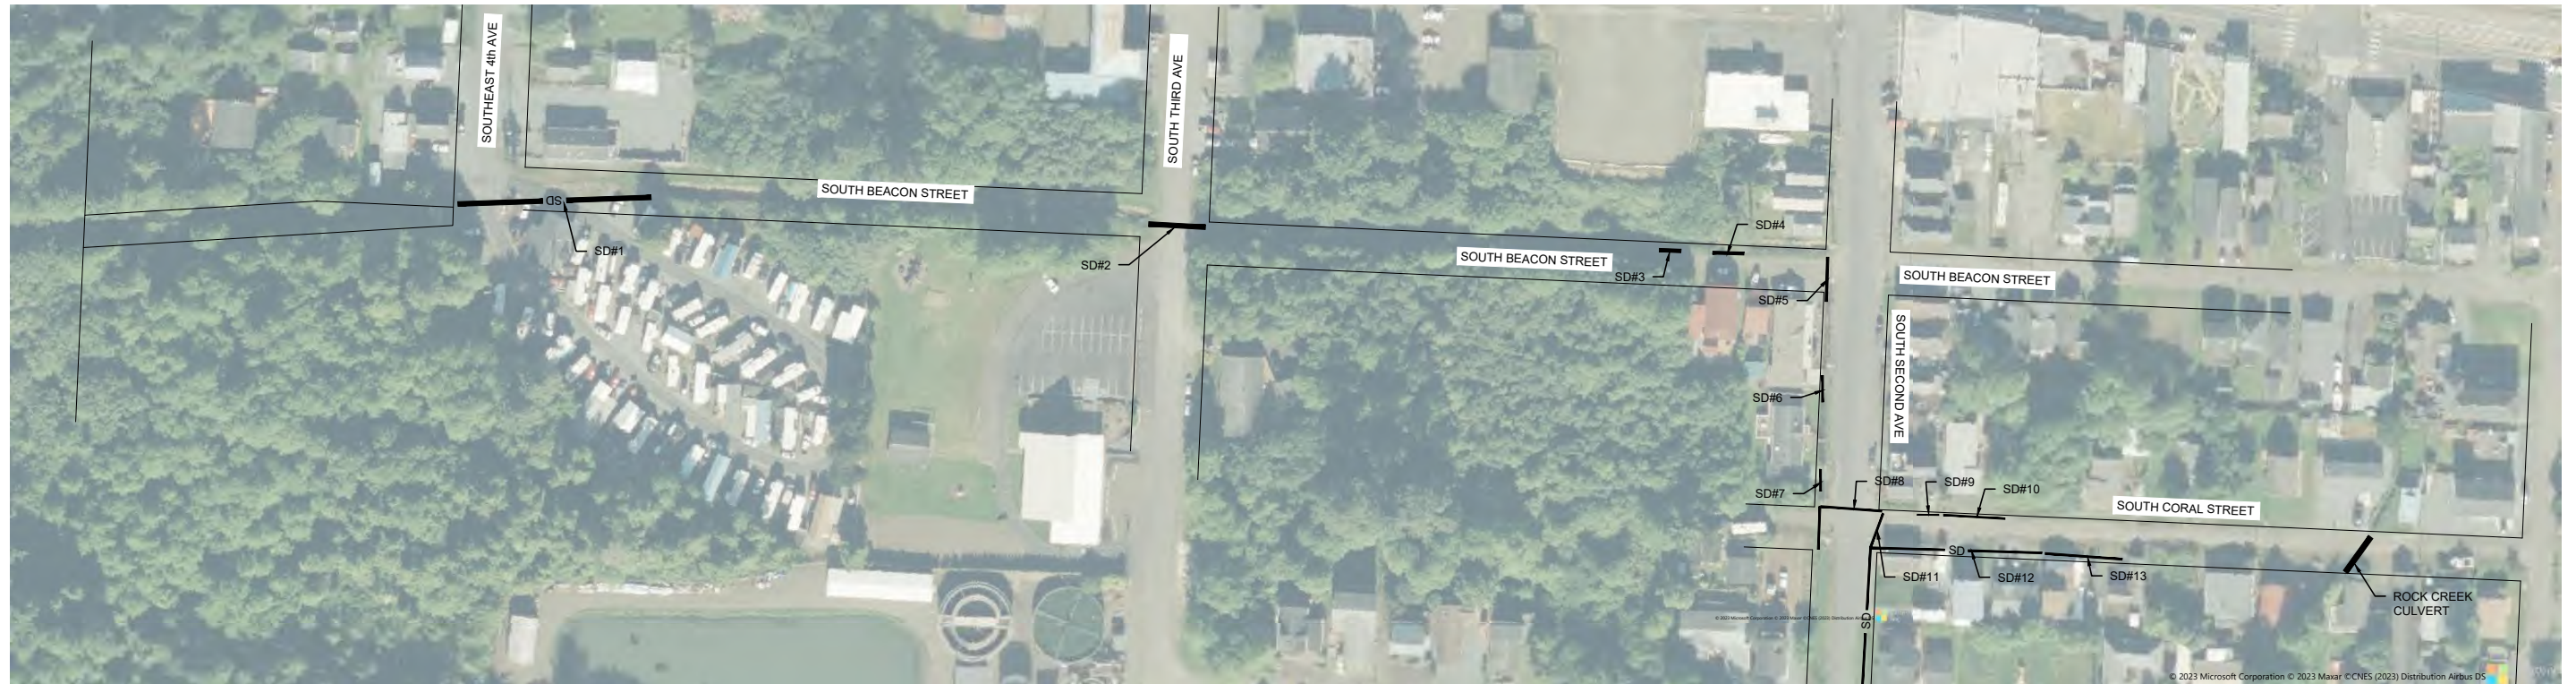
FIG.
1

STUDY AREA

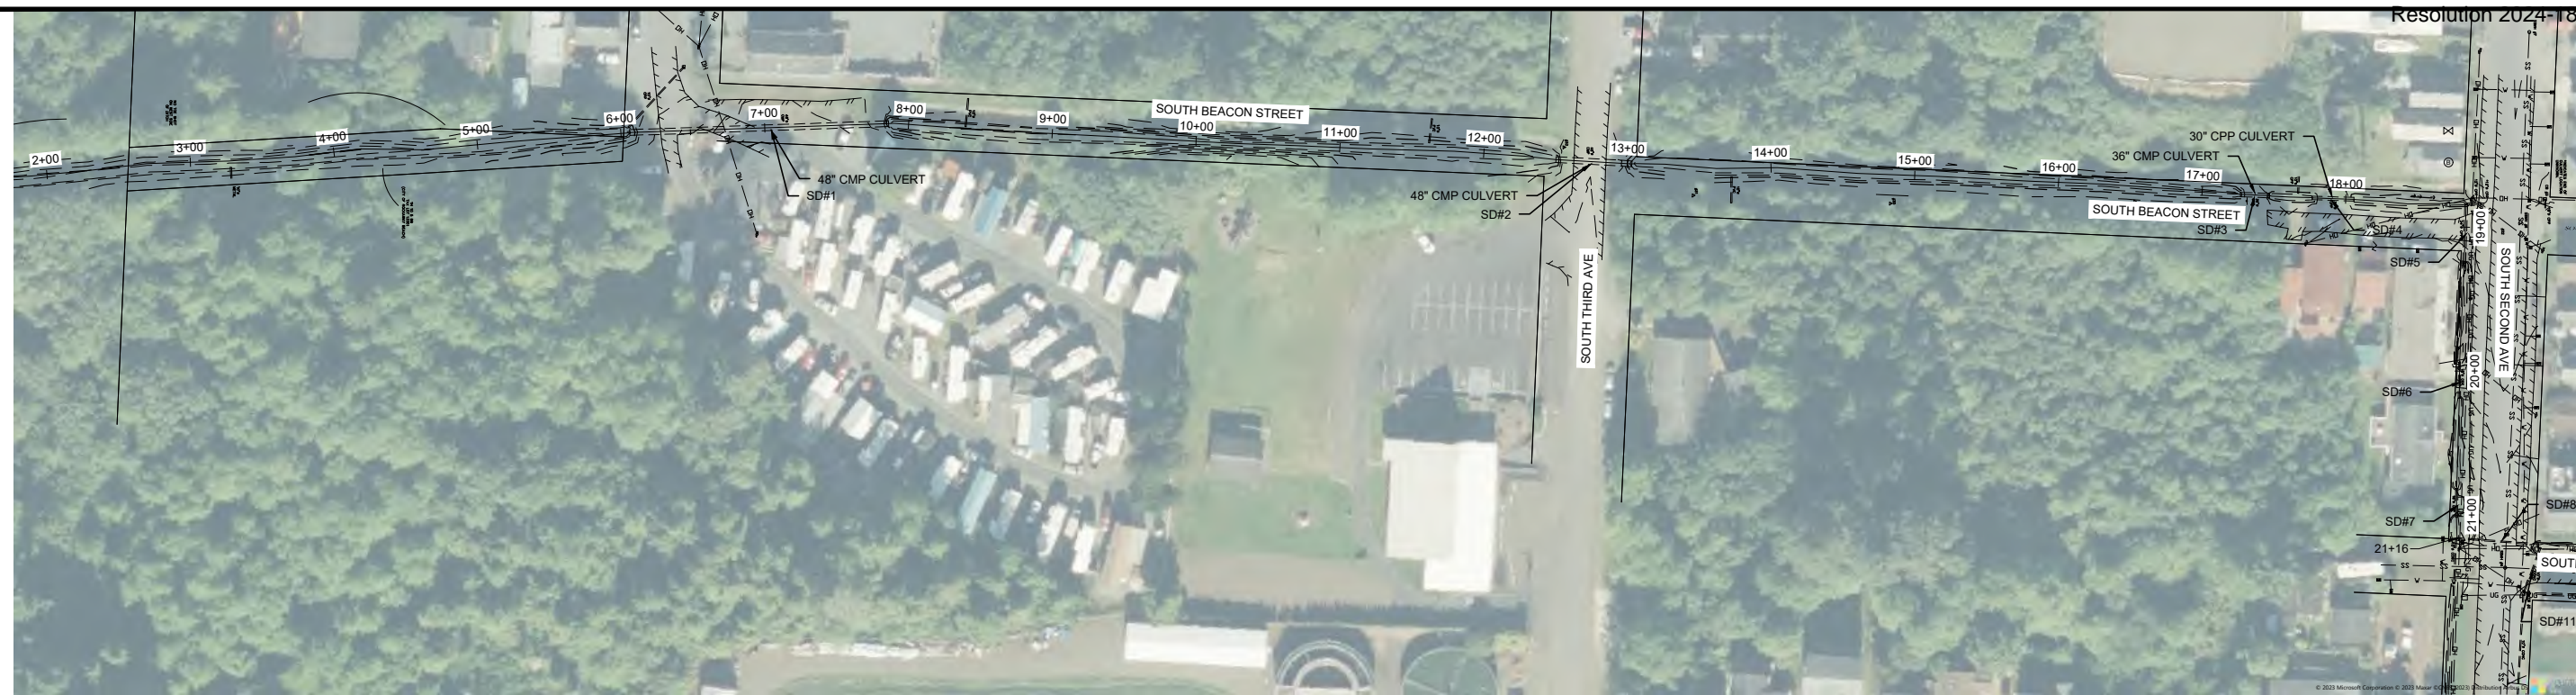
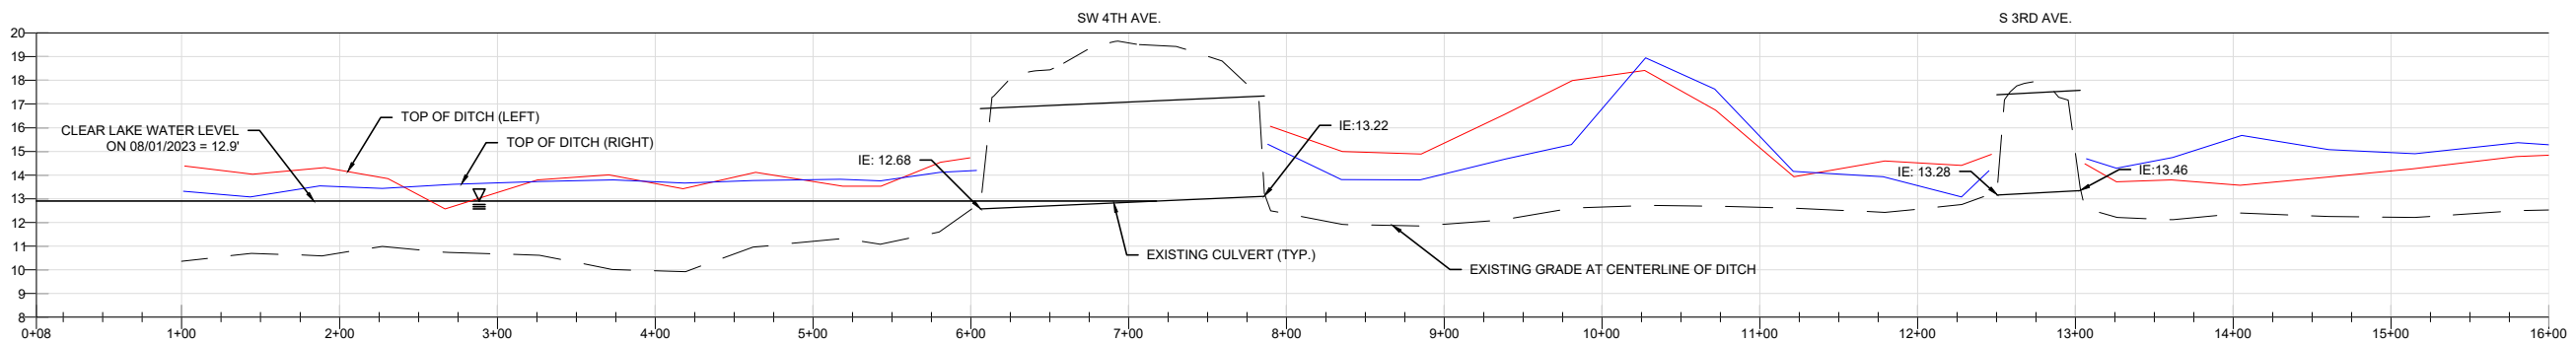
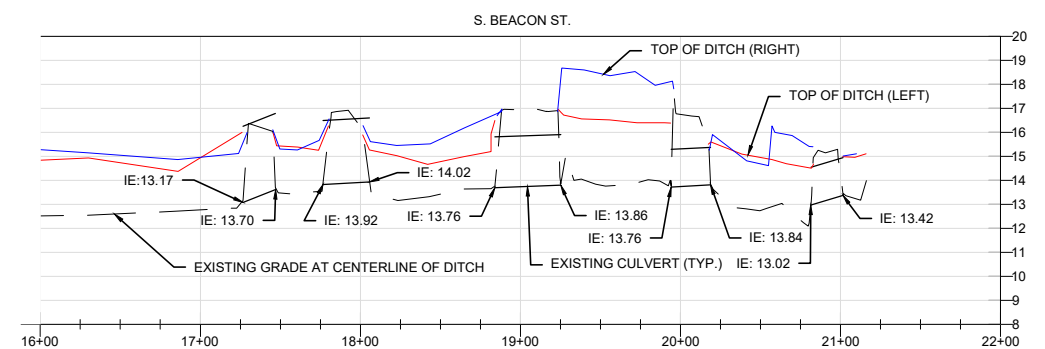
STANDARD PLAN VIEW STA 2+50 TO 21+16
HORIZONTAL SCALE: 1" = 120'

PROFILE VIEW STA 0+08 TO 16+00
HORIZONTAL SCALE: 1" = 120'
VERTICAL SCALE: 1" = 8"

PROFILE VIEW STA 16+00 TO 22+00
HORIZONTAL SCALE: 1" = 120'
VERTICAL SCALE: 1" = 8"

S BEACON ST DITCH PROFILE

The final stretch of ditch is the South Beacon Street Drainage Channel. This drainage channel along with the culverts are of adequate size to convey the stormwater to the point of discharge at Clear Lake. However, several culverts could be lowered to better facilitate drainage. The northernmost culvert has an invert elevation of 14.01'. This is more than a foot higher than the lowest invert upstream and only 9" below the lowest street elevation upstream. The plan and profiles of the existing South Beacon Street Ditch are included in the report appendices.
